NEWCASTLE COAL INFRASTRUCTURE GROUP  
COAL EXPORT TERMINAL

ANNUAL ENVIRONMENTAL MANAGEMENT REPORT  
2009

**July 2009**

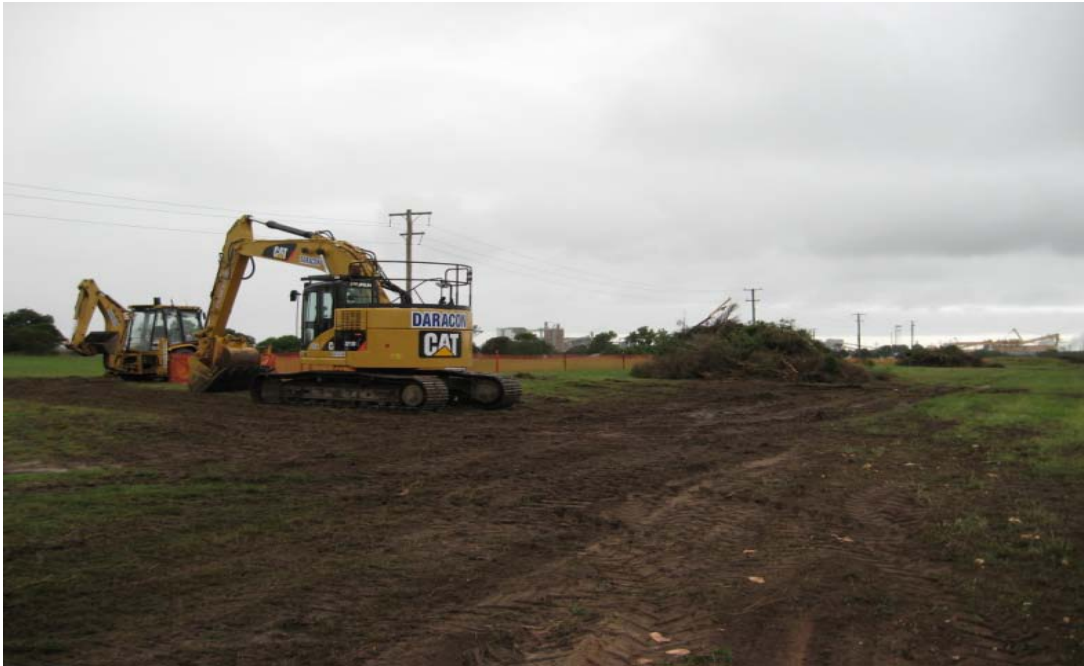
**Figure 2.1: Minor Vegetation Clearance**

Land preparation activities commenced on the NCIG Coal Export Terminal development site in early 2008. These works primarily consisted of minor clearing of vegetation and topsoil stripping (see Figure 2.1) and the establishment of perimeter fencing and site accommodation (see Figure 2.2). These activities were conducted in accordance with the Project Approval and CEMP.

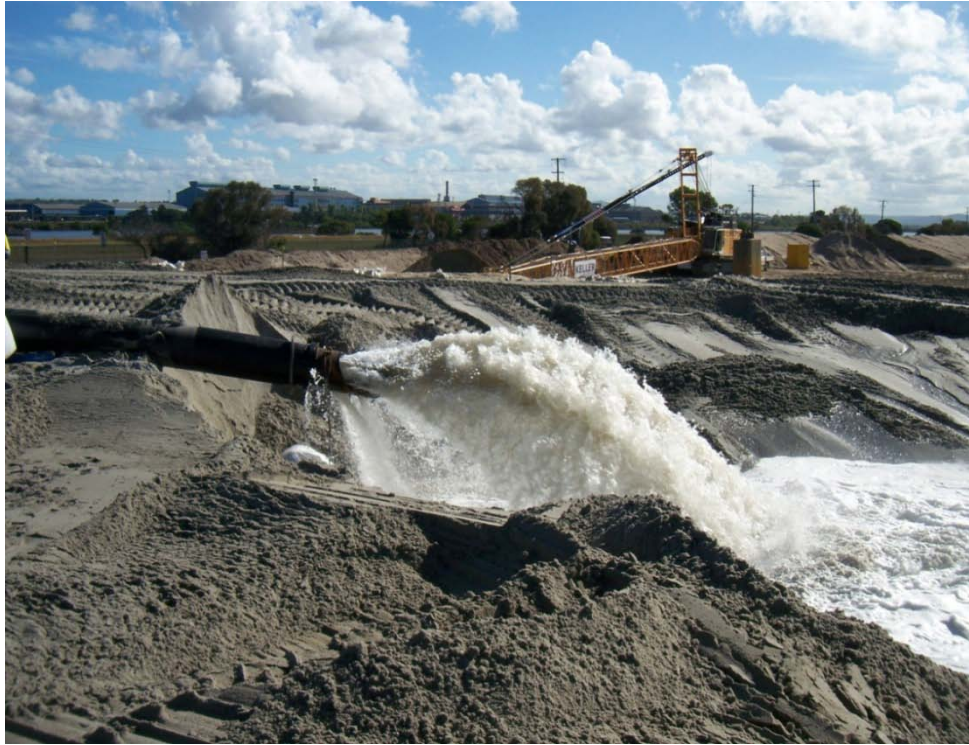
**Figure 2.3: Sand Reclamation**

Construction of Stage 1 of the NCIG Coal Export Terminal development commenced in April 2008 with the initiation of the reclamation of general fill material (sand) from the Hunter River (see Figure 2.3) and ground improvement works (see Figure 2.4)

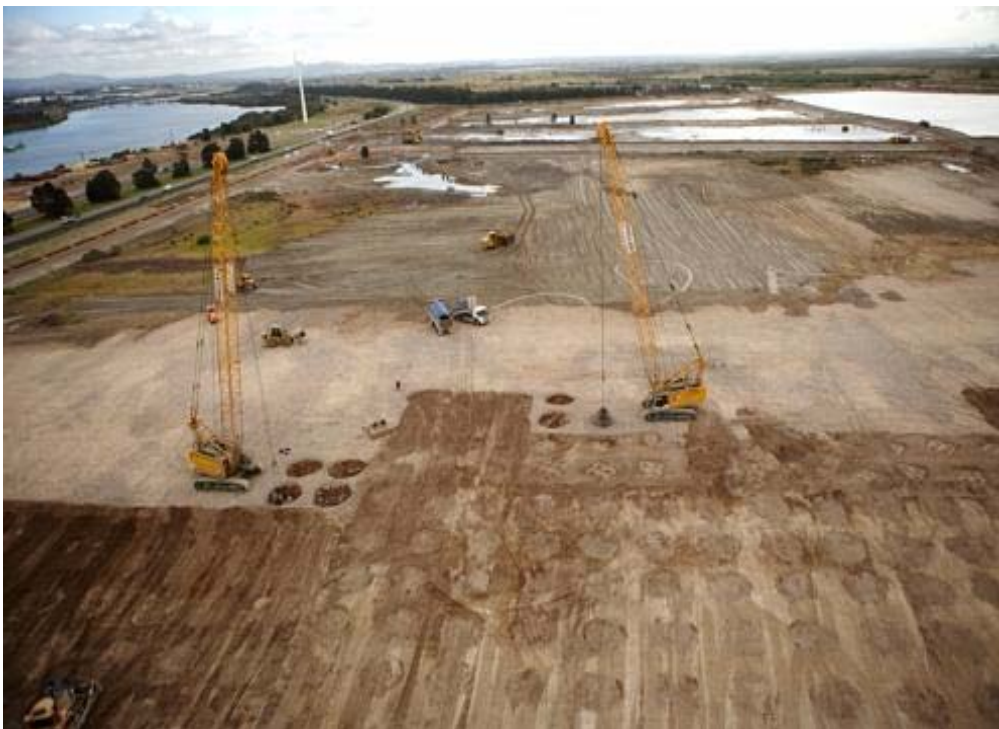
**Figure 2.4: Ground Improvement Works**

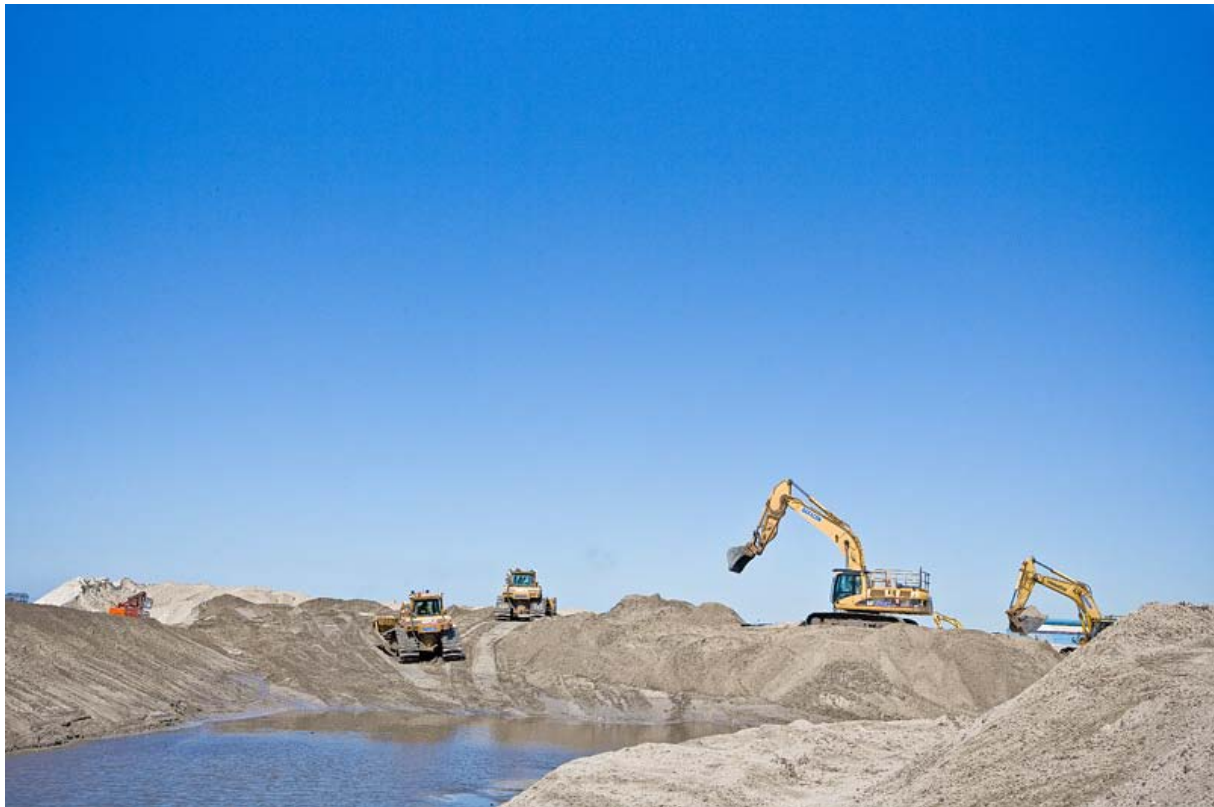
**Figure 2.5: Sand Reclamation Activity**

- Reclamation of approximately 3 million cubic metres of sand and rock from the Hunter River which was subsequently utilised as preload and engineering fill for construction of the coal storage area, rail corridor and wharf facilities (see Figure 2.3 and Figure 2.5).

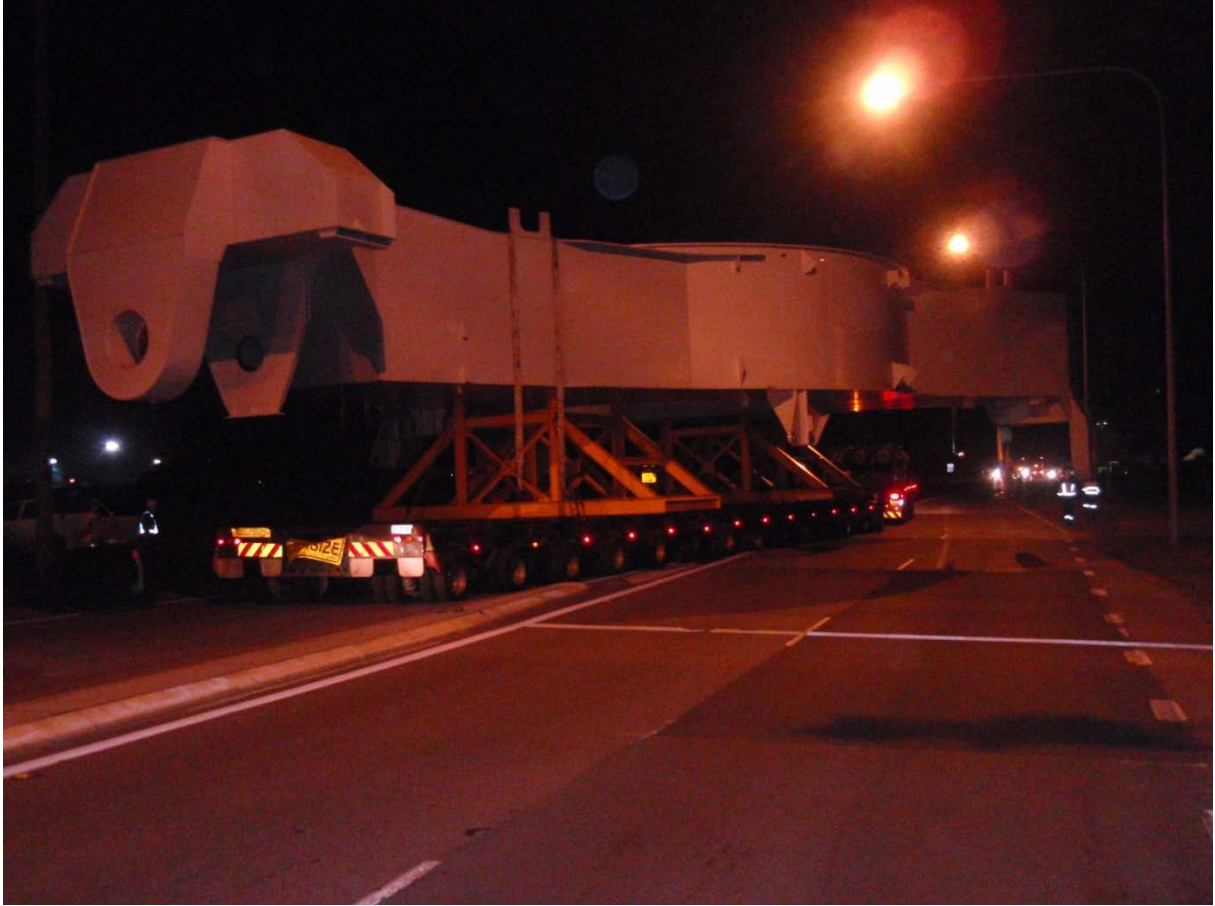
**Figure 2.6: Stacker/Reclaimer Component Delivery**

- Delivery of major components of stacker/reclaimers from Korea (see Figure 2.6).
- Partial construction of wharf facilities (see Figure 2.7).
- Construction of the rail infrastructure formation (see Figure 2.8).

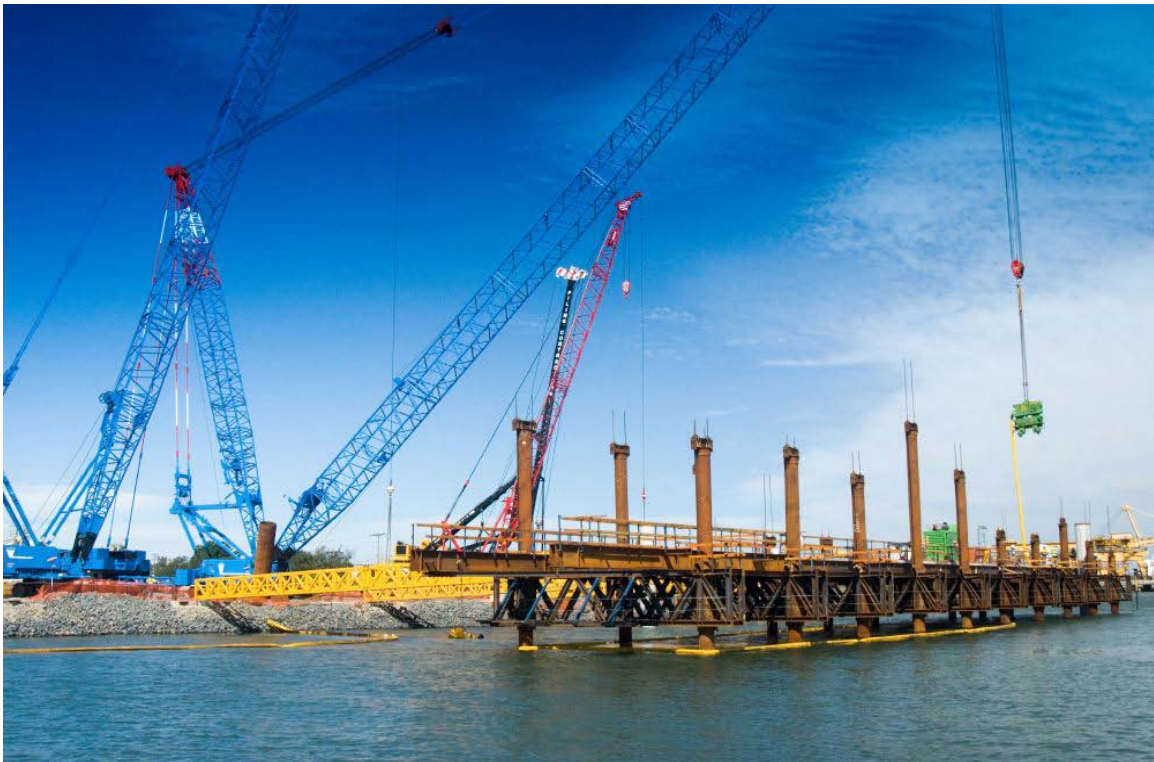
**Figure 2.7: Wharf Construction Works**

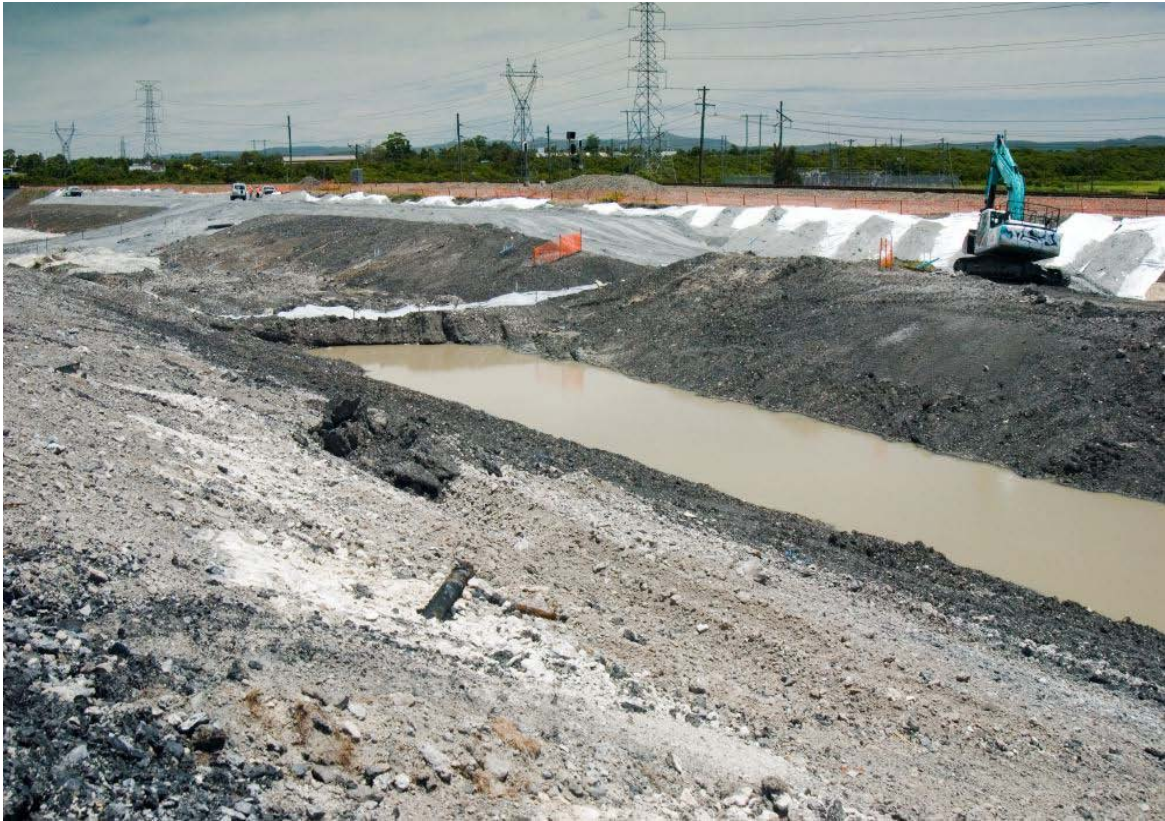
**Figure 2.8: Rail Formation Construction**

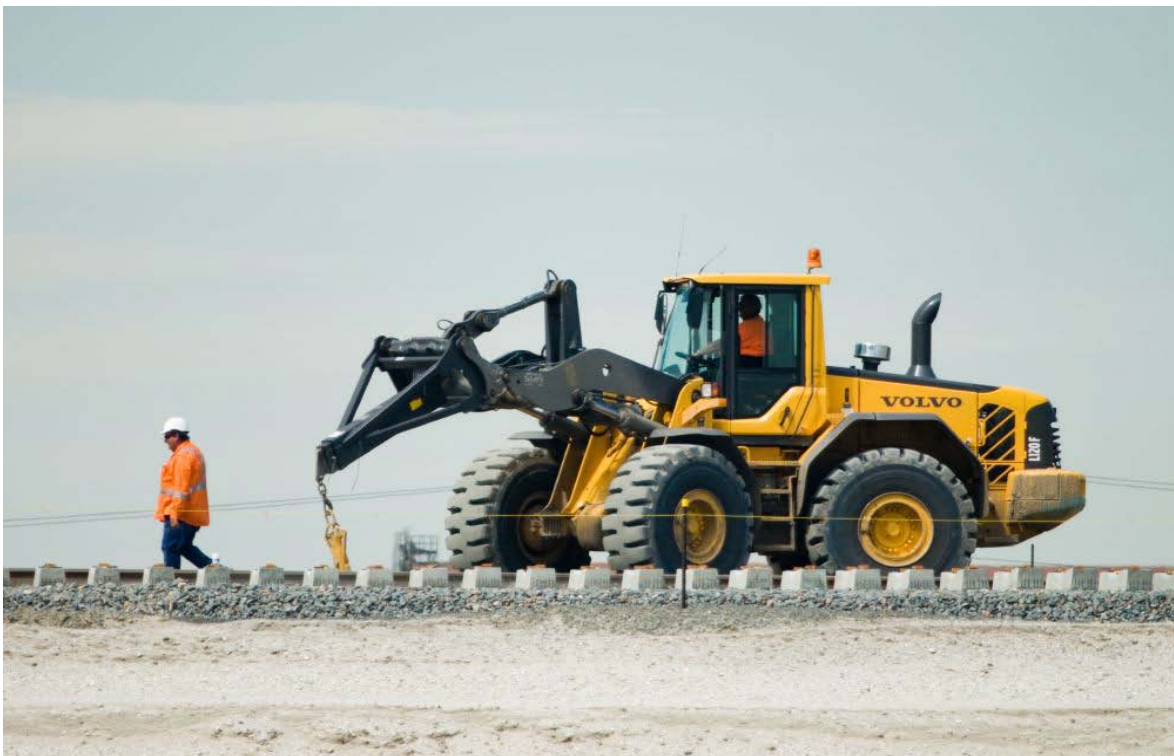
**Figure 2.9: Rail Instillation Works**

- Commencement of construction of train unloading station.
- Partial construction of rail spurs, rail sidings and rail loops (see Figure 2.9).
- Development of access roads and internal roads.

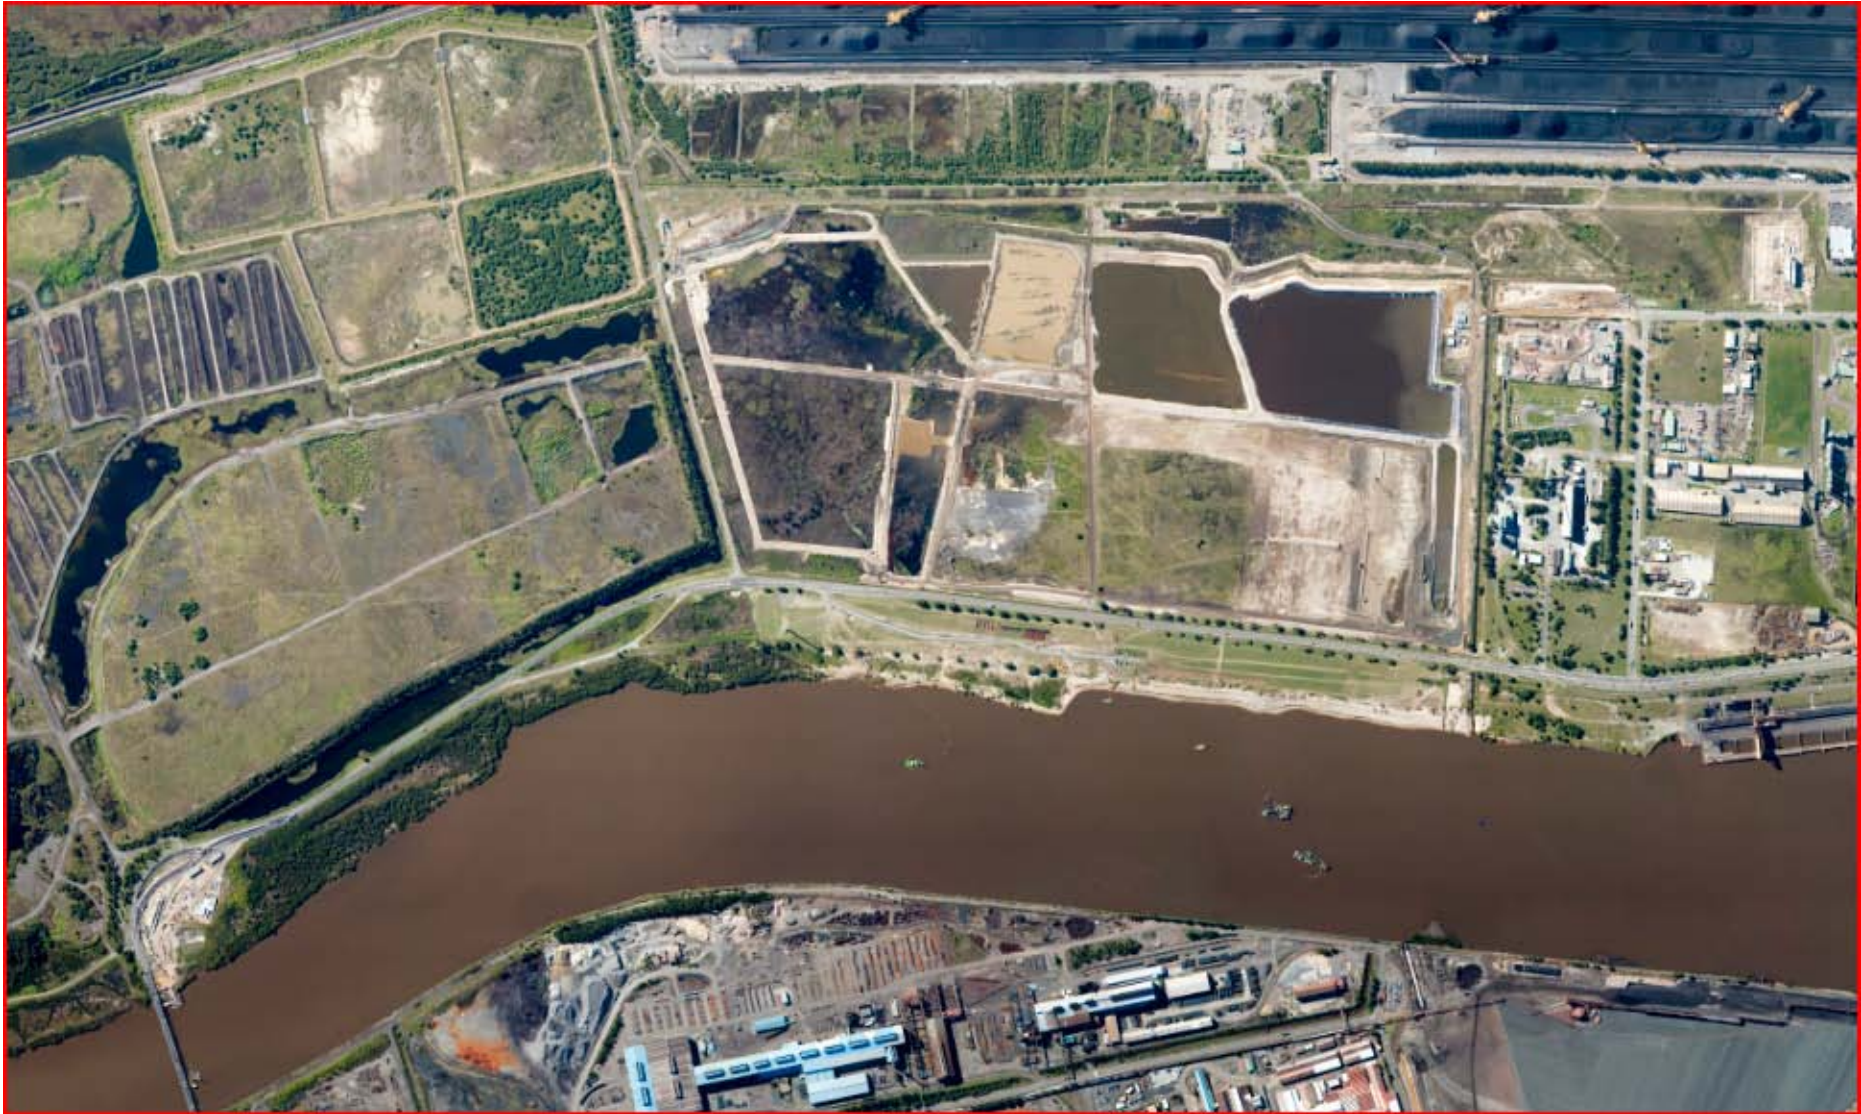
Figure 2.10: April 2008 Aerial Photograph of Project

The overall progress of construction activities on the project is clearly illustrated through a comparison of aerial photographs taken in April 2008 (see Figure 2.10) and March 2009 (see Figure 2.11).

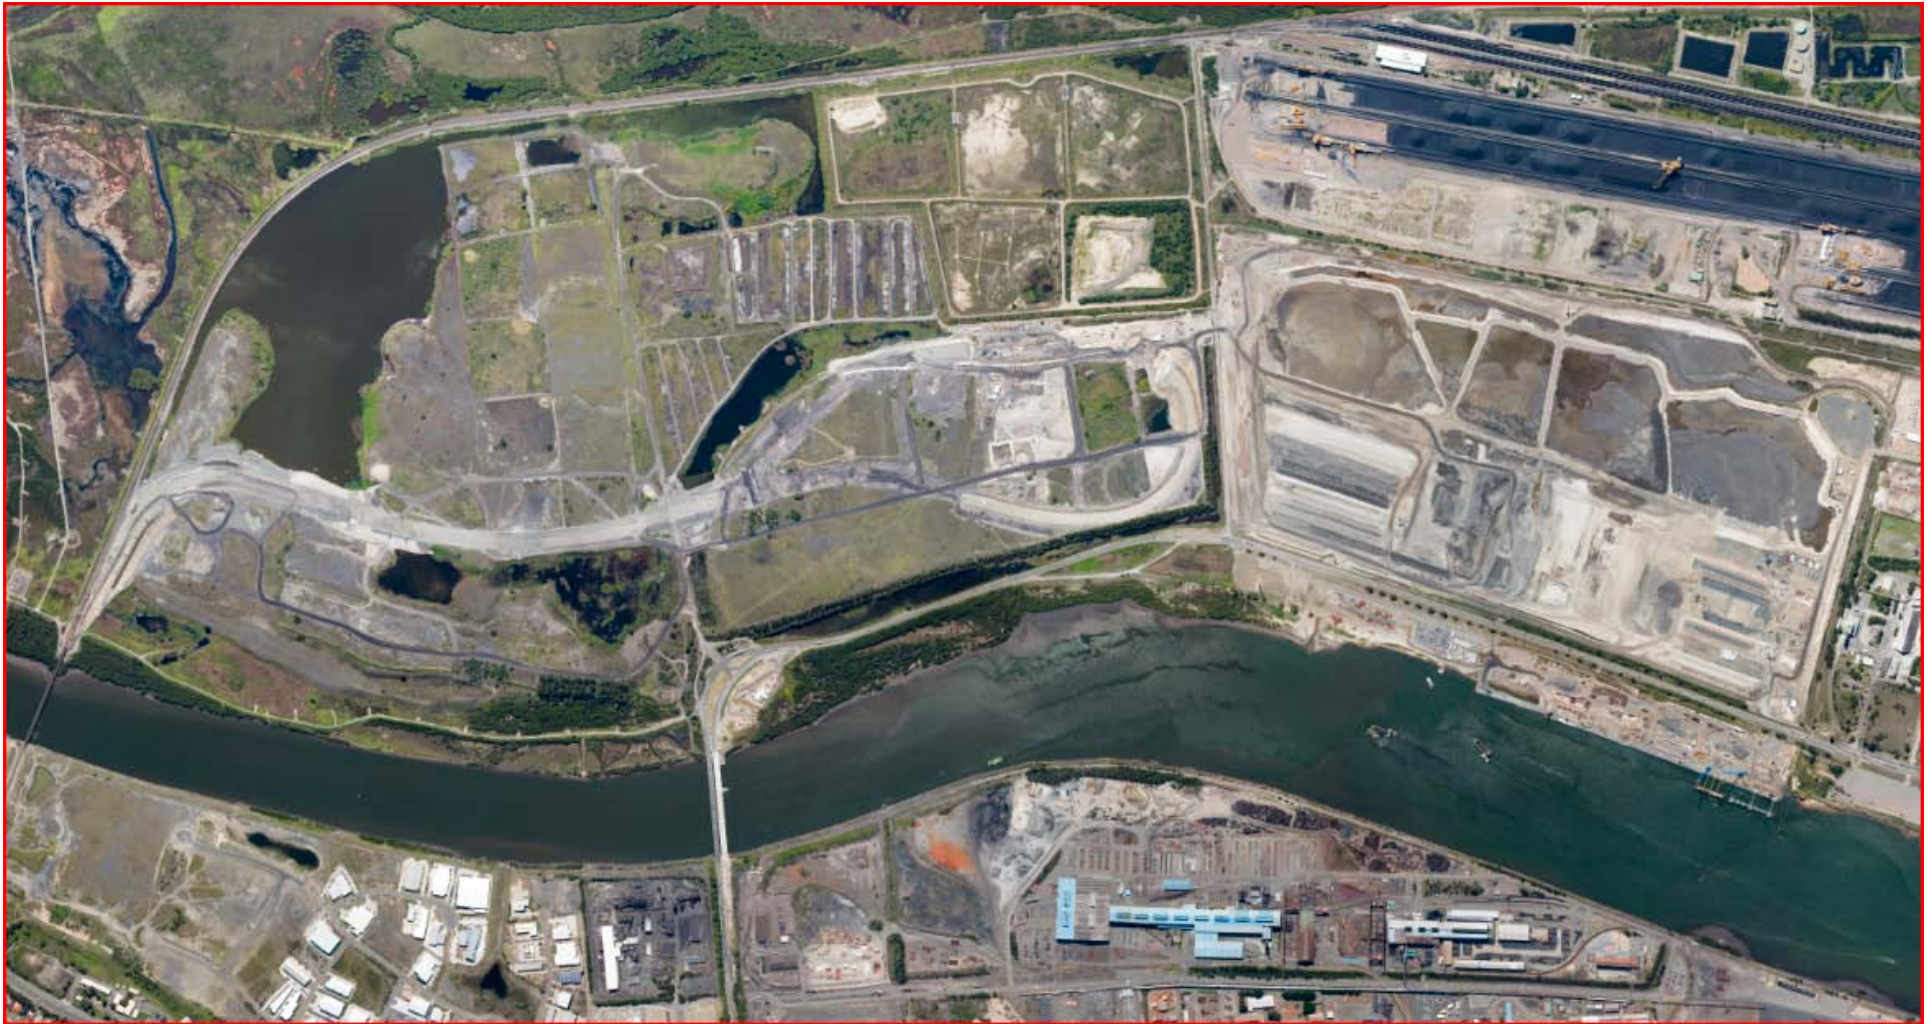
Figure 2.11: March 2009 Aerial Photograph of Project

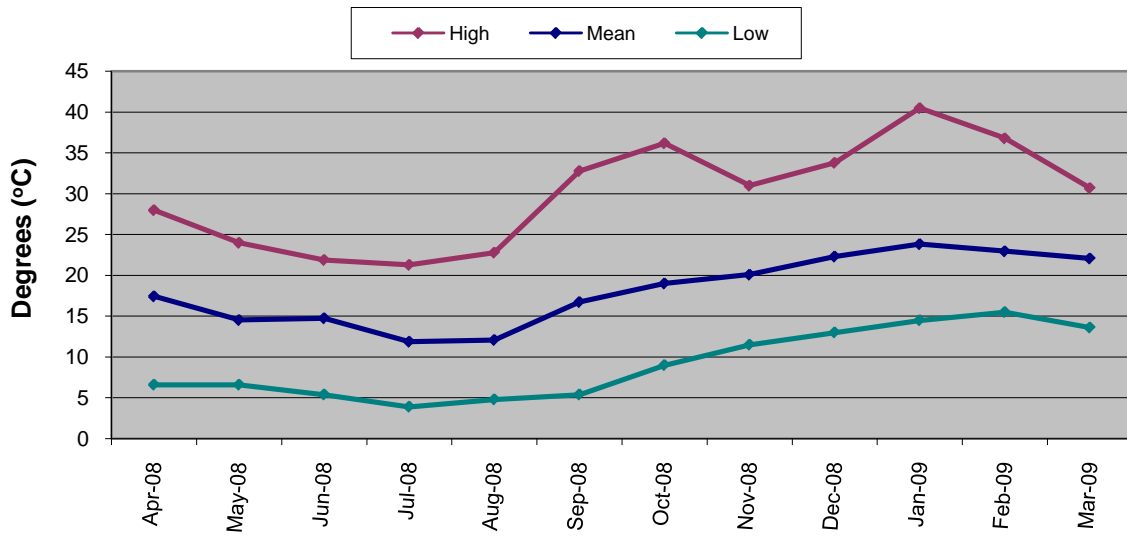
**Figure 3.1.2: Average Temperature**

The monthly statistical information for each of the meteorological monitoring parameters is detailed in Table 3.1.2. From this information Figure 3.1.2 illustrates the variation in average temperature during the reporting period. These variations from the winter to summer seasons are the expected seasonal norms.

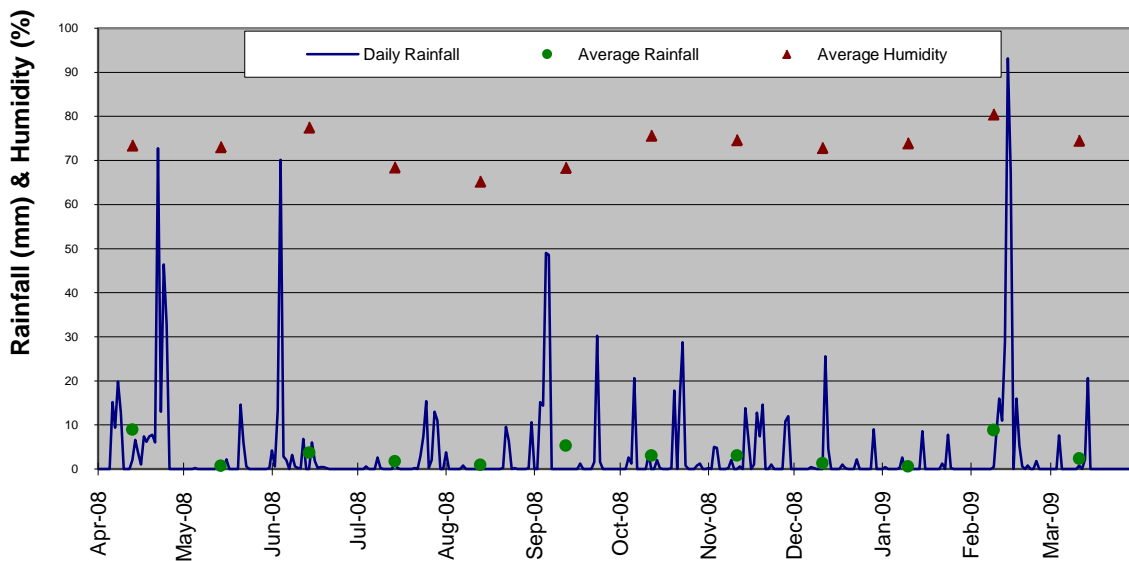
**Figure 3.1.3: Daily and Average Rainfall**

The daily rainfall recorded at the project site is illustrated by Figure 3.1.3. A total of 1238mm of rain was received on the site during the reporting period with significant rainfall events recorded in April 2008, June 2008 and February 2009. Relatively consistent rainfall was also received during the September to December 2008 period.

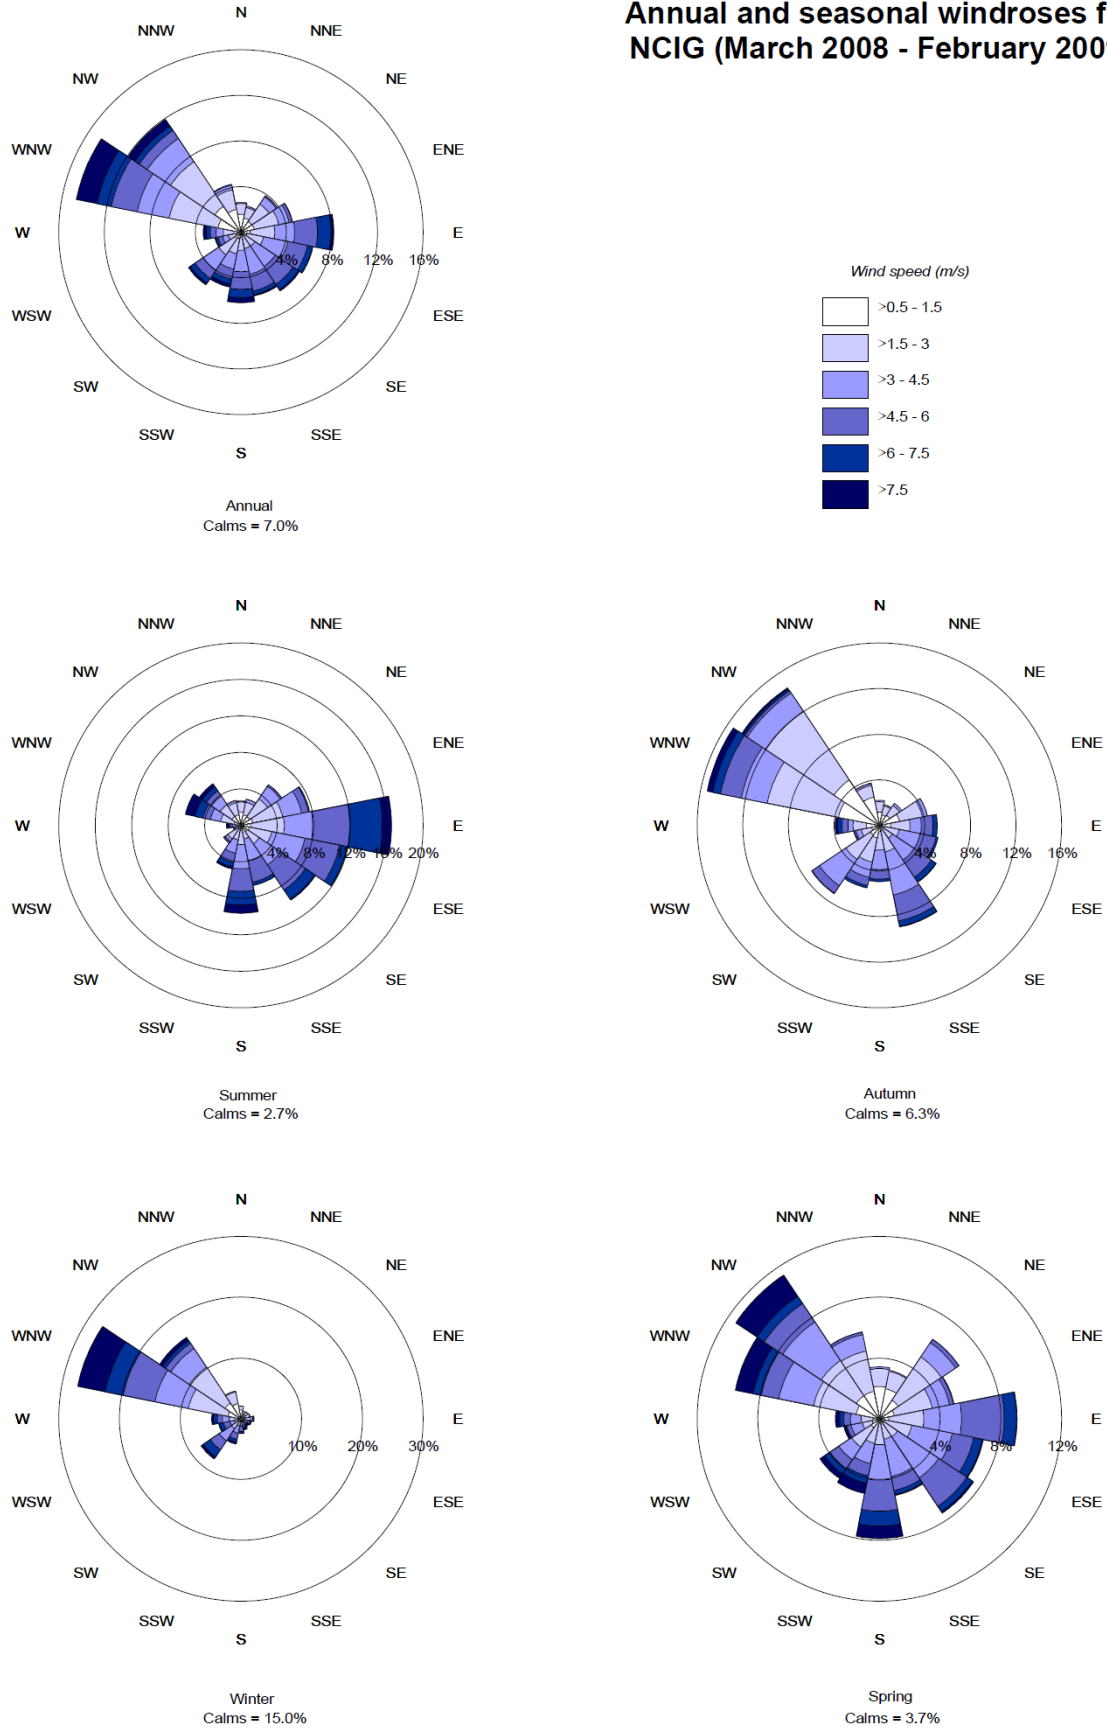
**Annual and seasonal windroses for NCIG (March 2008 - February 2009)**

**Figure 3.1.4: Seasonal Wind Conditions**

Figure 3.1.4 also illustrates the seasonal variation in wind speed and direction at the site which highlights that the dominant conditions in relation to wind has a westerly aspect during the autumn and winter period and is predominately easterly during the summer period.

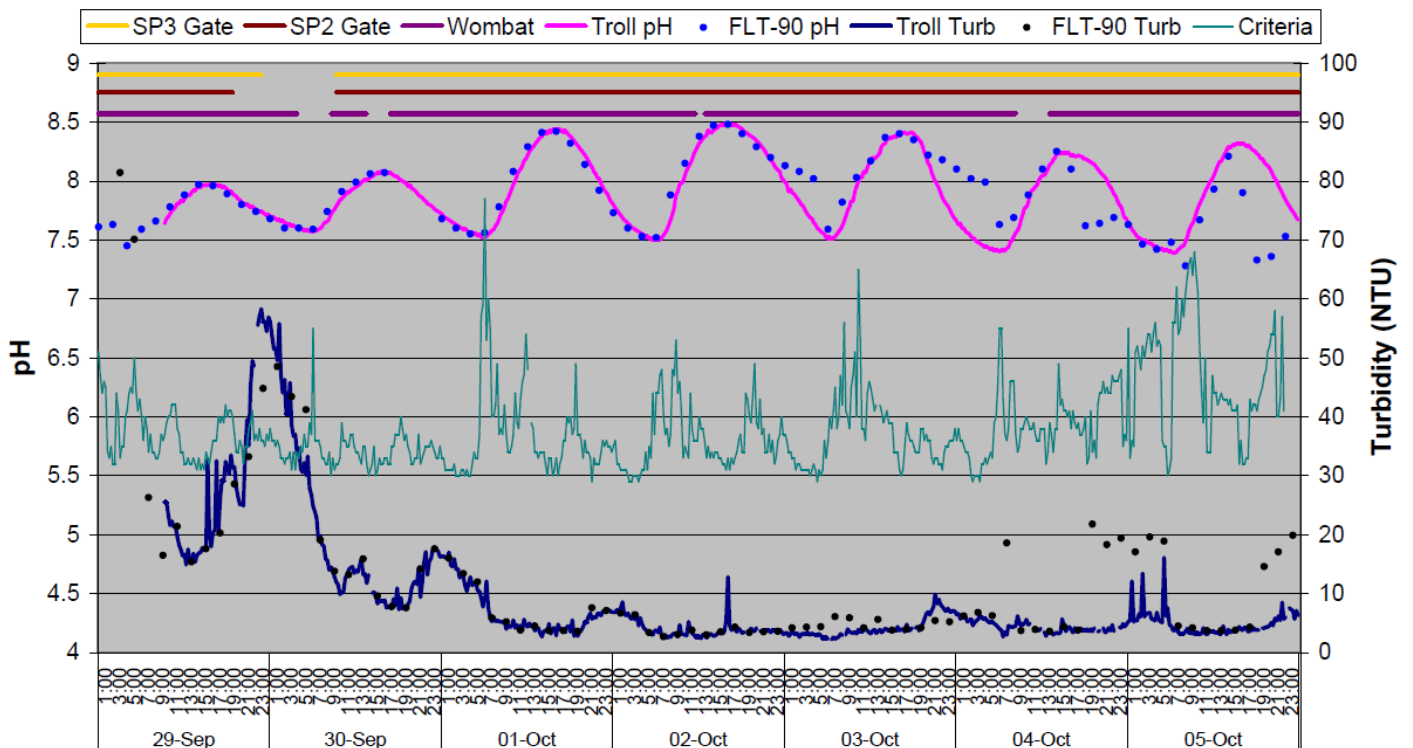
**EPL12 - pH and Turbidity readings - Week ending the 5<sup>th</sup> October**

**Figure 3.3.3: Example of Water Management Procedure**

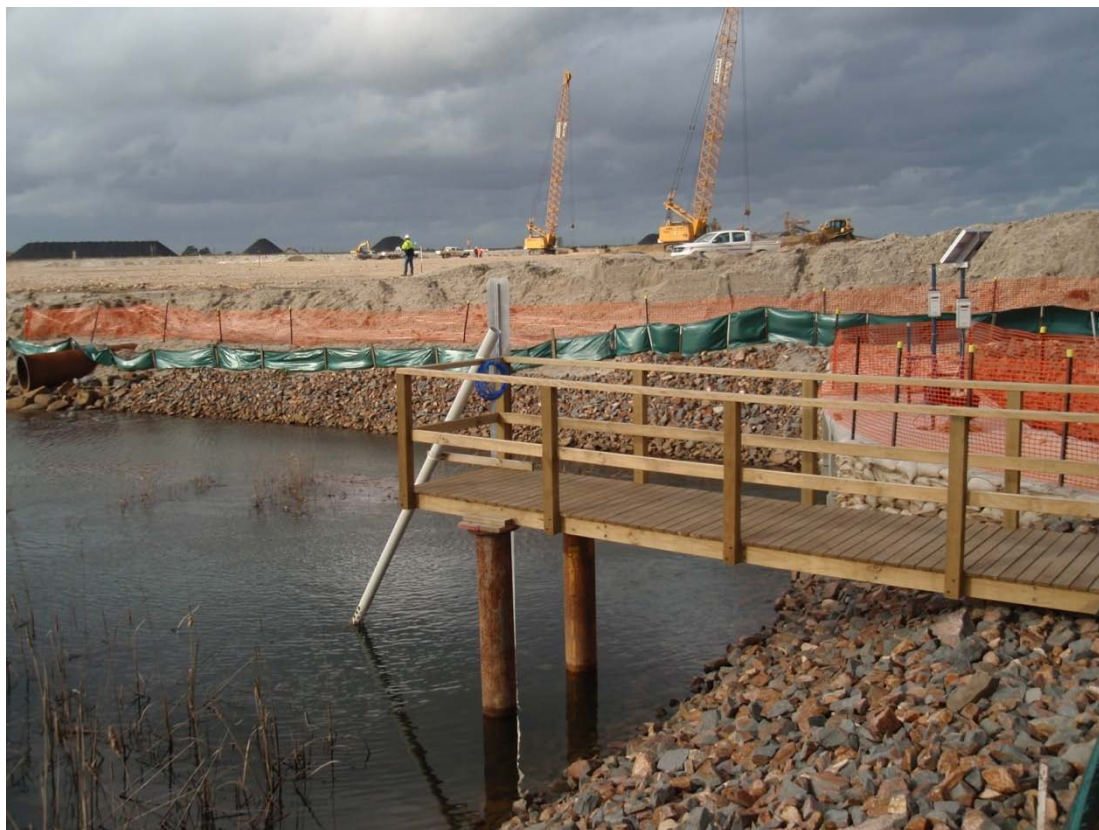
**Figure 3.3.4: Monitoring location at EPL12**

- Continuous monitoring at discharge location EPL12 (troll turb) (see Figure 3.3.4)
- Discrete monitoring at settlement pond release points (FLT-90 turb)
- Turbidity criteria (river background + 25NTU)
- pH monitoring both continuous and discrete (criteria is 6.5 – 8.5)
- Operation of release points from the hydraulic discharge structures SP2 and SP3 and sand dredge (Wombat) illustrated by horizontal lines with gaps in the lines indicating release points closed and dredge not operating.

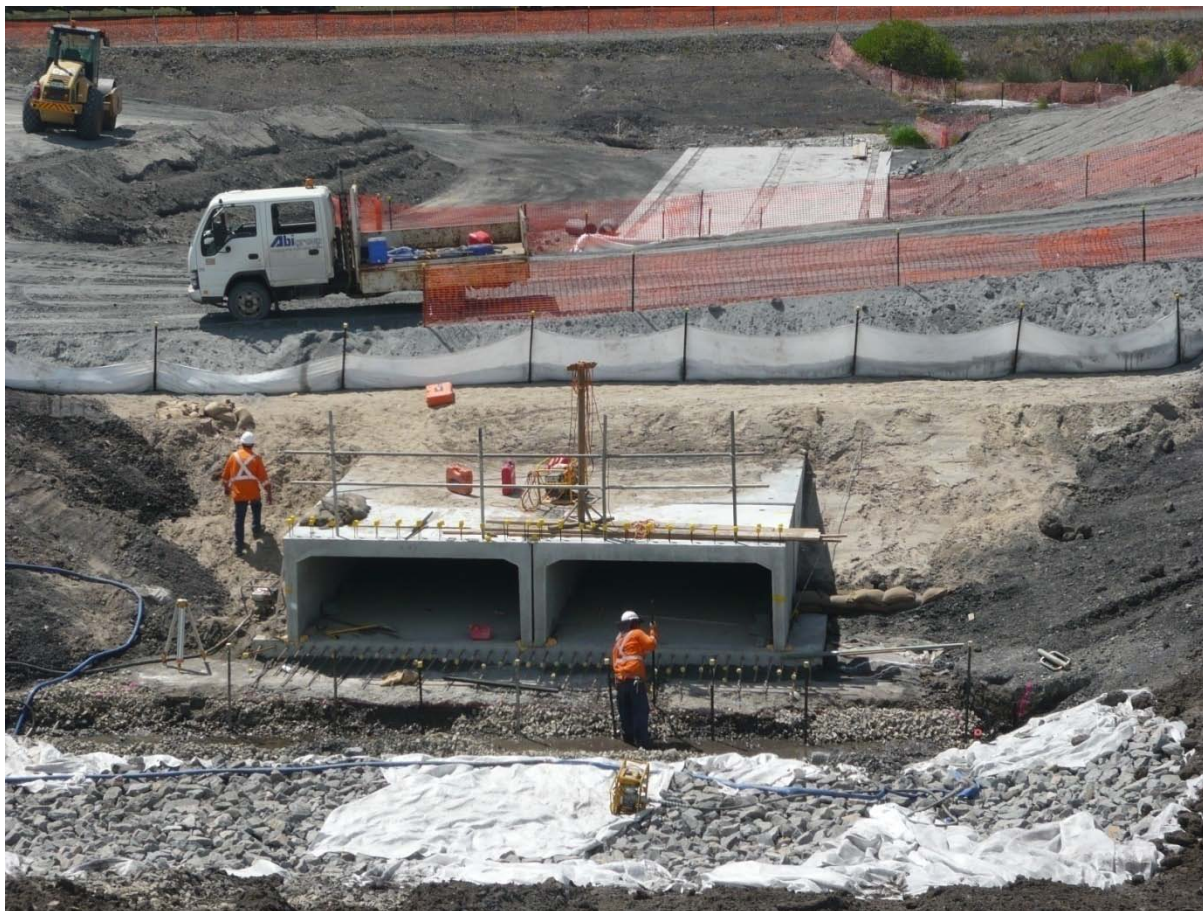
**Figure 3.4.1: Construction of Stormwater Infrastructure:**

A network of permanent stormwater structures is also being constructed to manage runoff around the site. All long-term site water management structures are lined with low permeability materials (e.g. compacted clay) to minimise the potential for leakage. Water management structures are designed with sufficient capacity for a 1 in 100 year average recurrence interval (ARI) rainfall event. The construction of these structures was ongoing during the reporting period as illustrated by Figure 3.4.1.

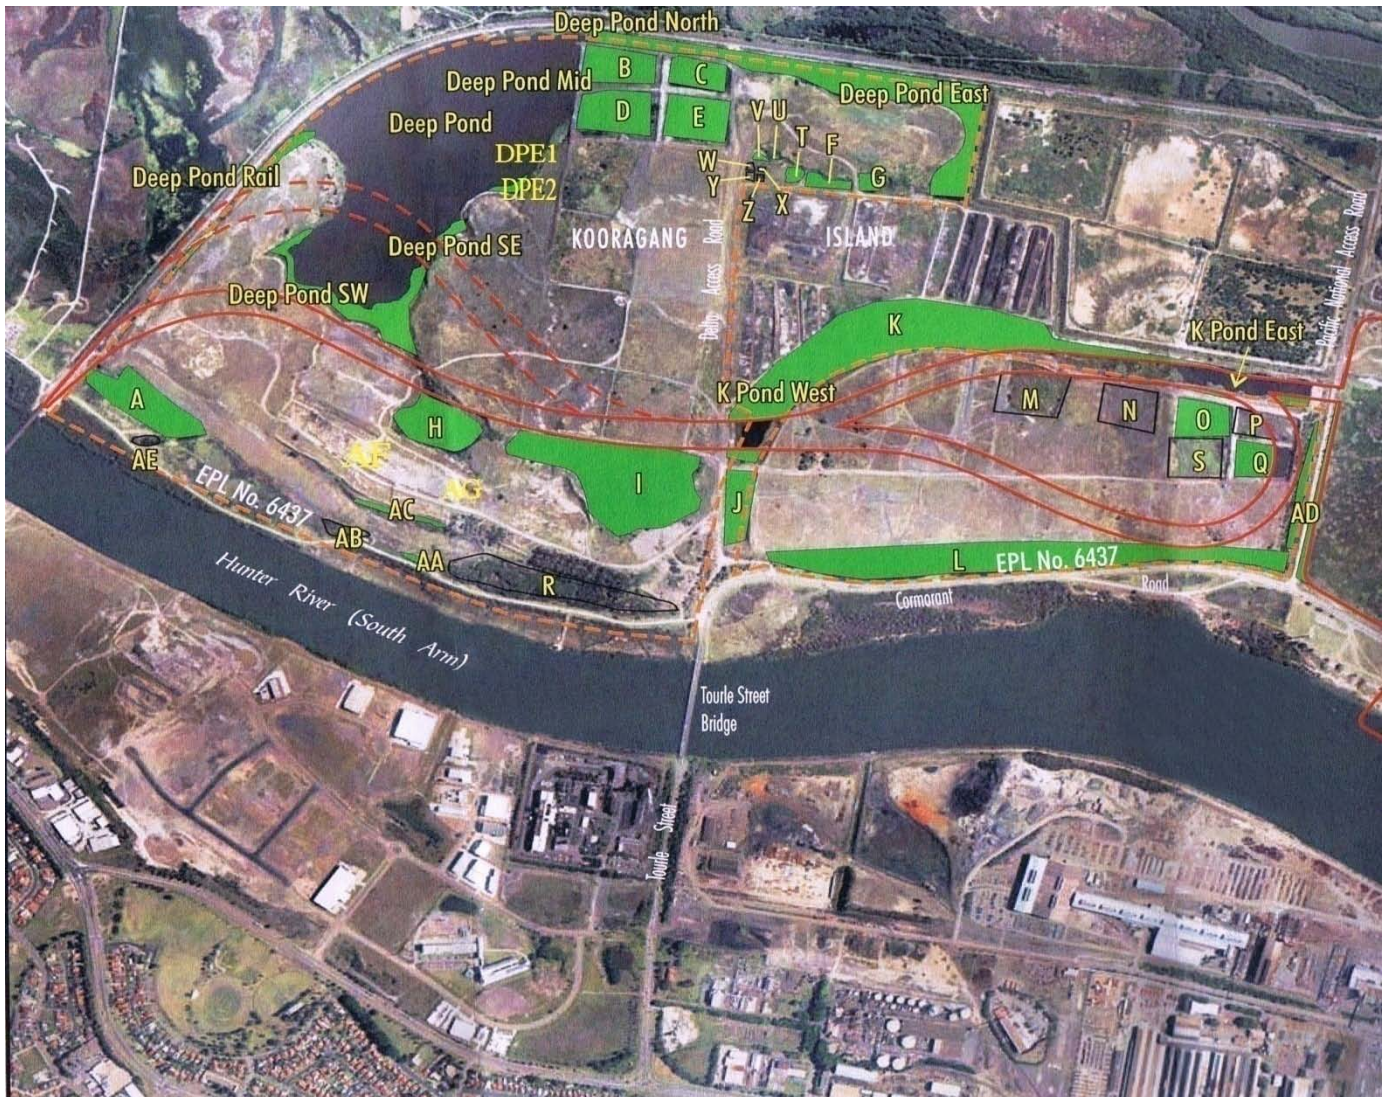
**Figure 3.10.2: Green and Golden Bell Frog Habitat Areas.**

Known and potential Green and Golden Bell Frog habitat is located across the Project site and surrounds. Project disturbance to habitat would include Big Pond which would be fully infilled and Ponds H, K and Q which would be partially disturbed (see Figure 3.10.2). However, most of the known and potential Green and Golden Bell Frog habitat recorded across the Project site and surrounds would not be directly disturbed by the Project (i.e. Ponds A, B, C, D, E, F, G, I, J, L, O, T, U, V, AA, AC, AD).
