NEWCASTLE COAL INFRASTRUCTURE GROUP
COAL EXPORT TERMINAL

ANNUAL ENVIRONMENTAL MANAGEMENT REPORT
2010

July 2010

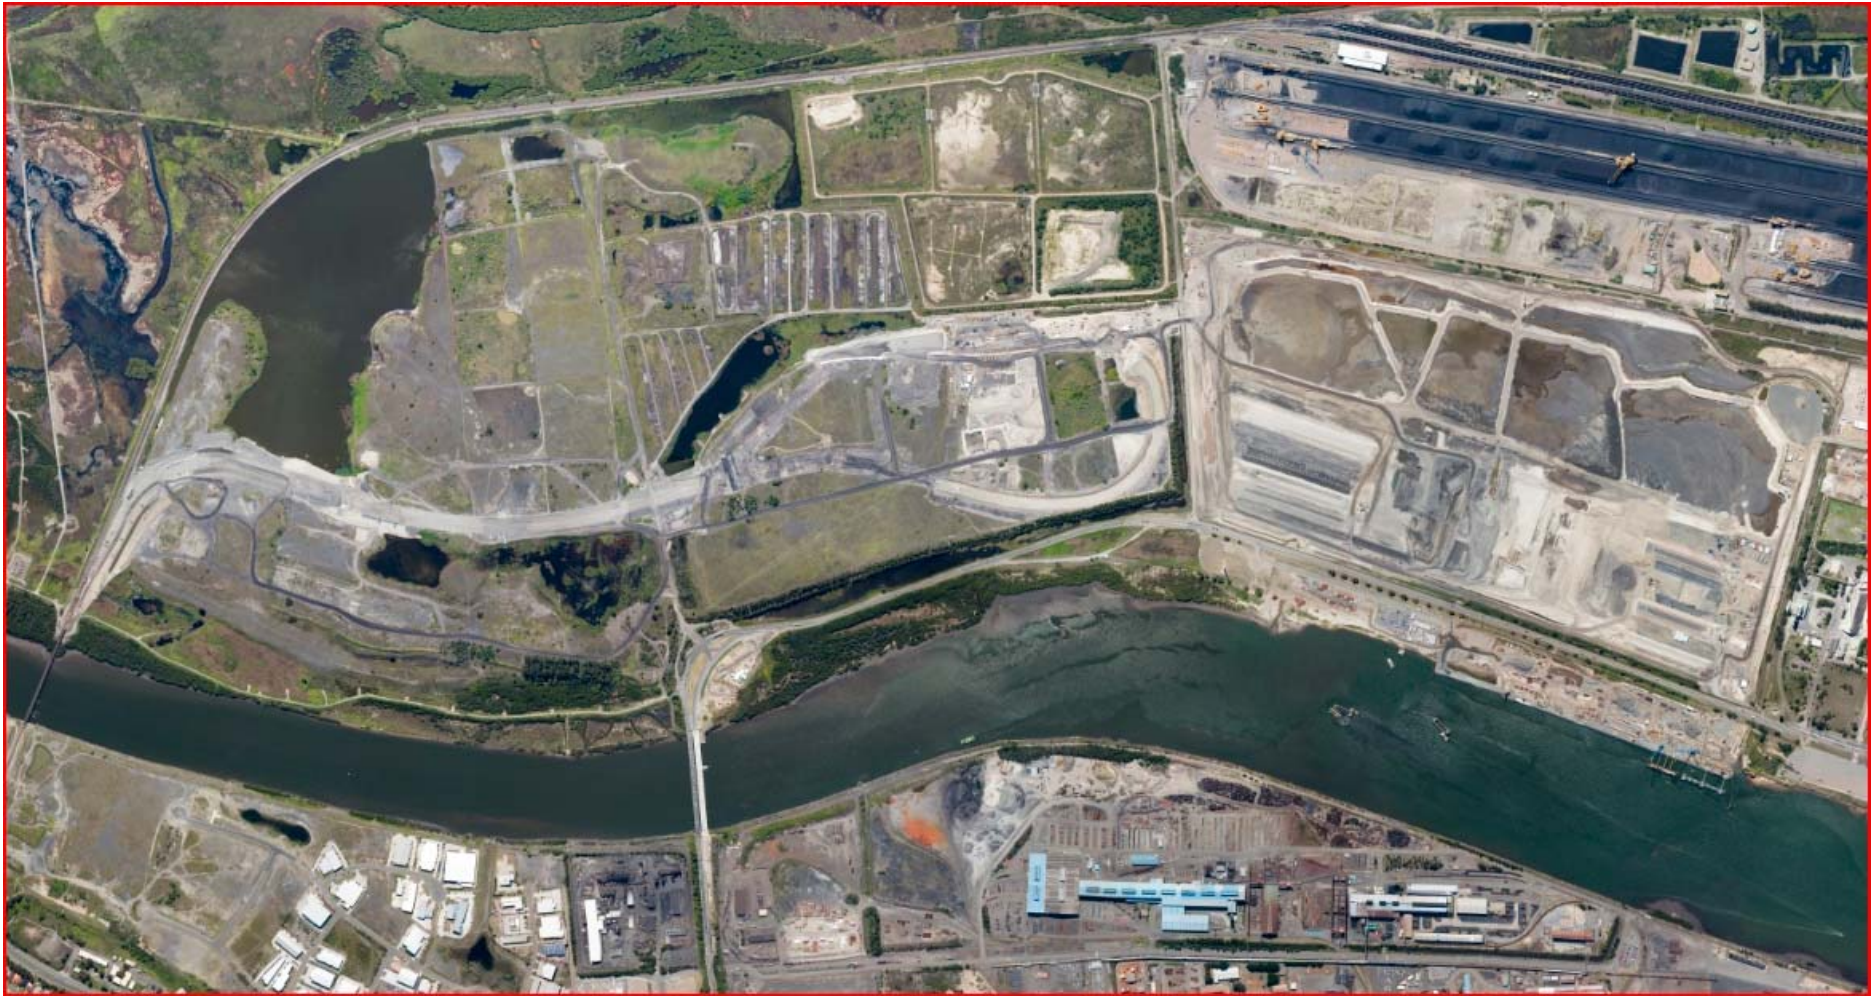
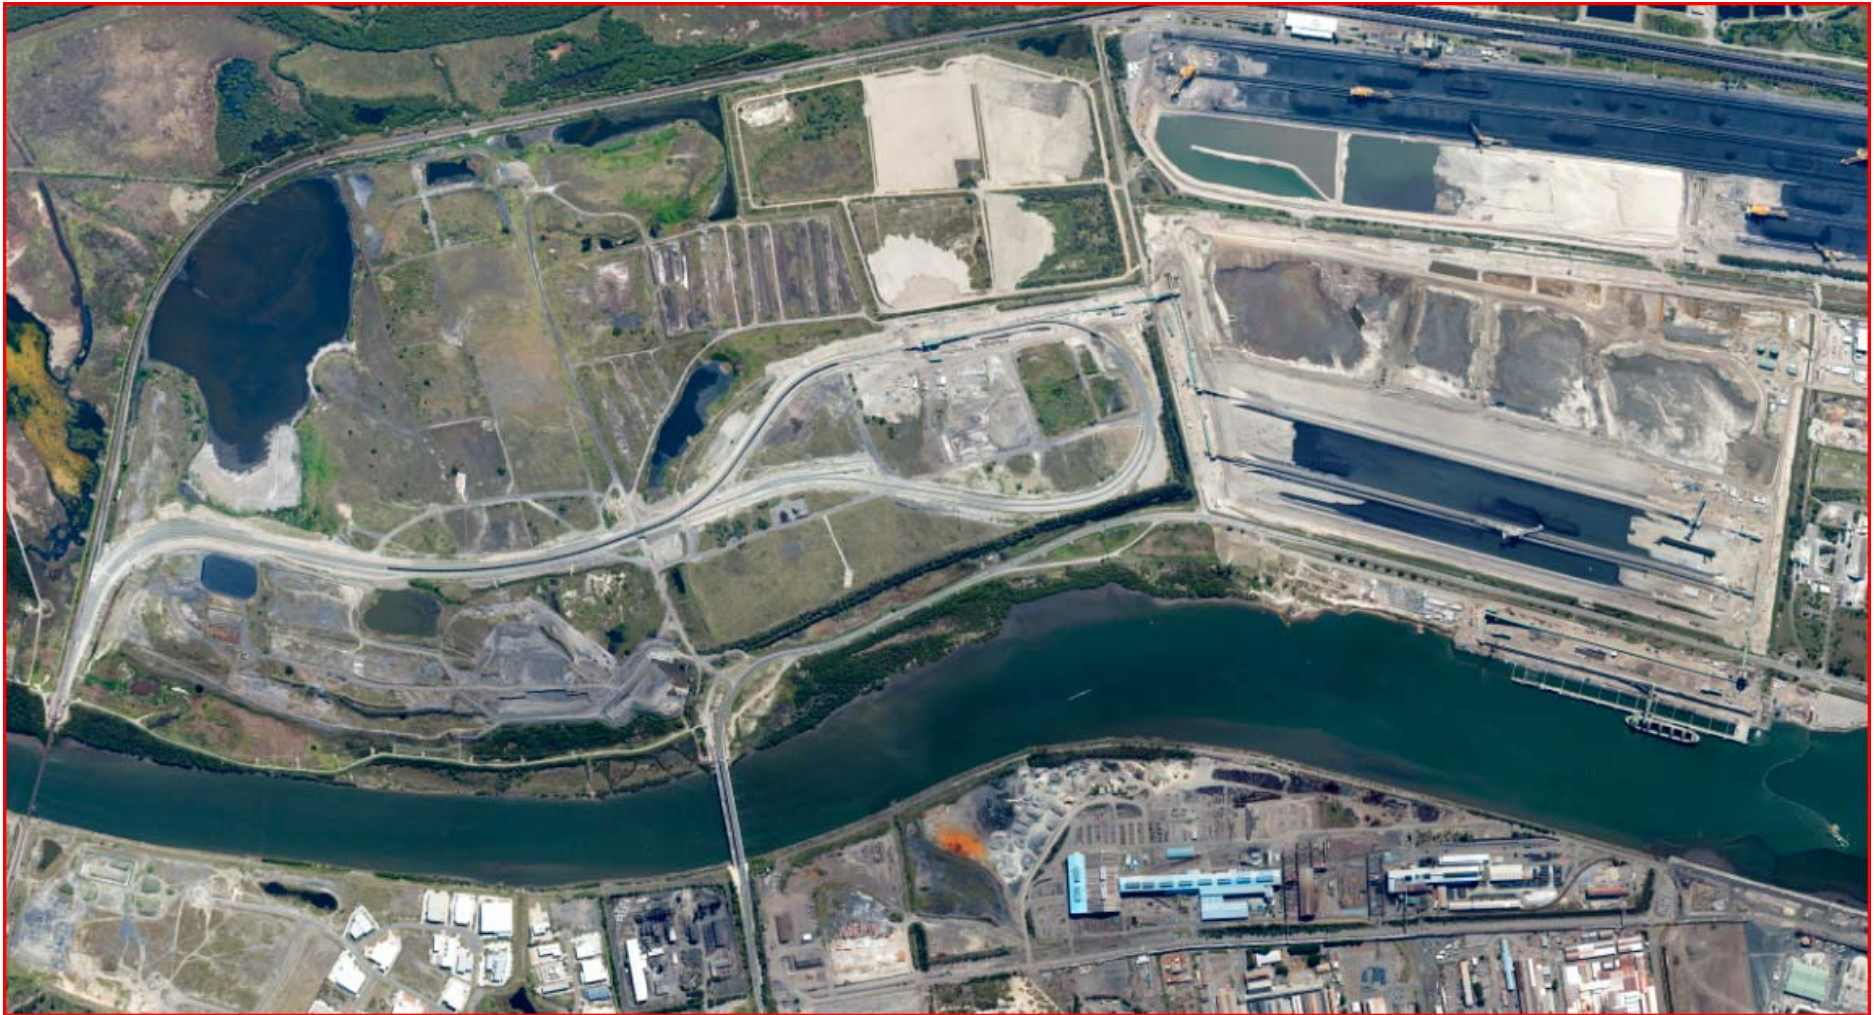
Figure 2.13: March 2009 Aerial Photograph of Project

The overall progress of construction activities on the project is clearly illustrated through a comparison of aerial photographs taken in March 2009 (see Figure 2.13) and March 2010 (see Figure 2.14).

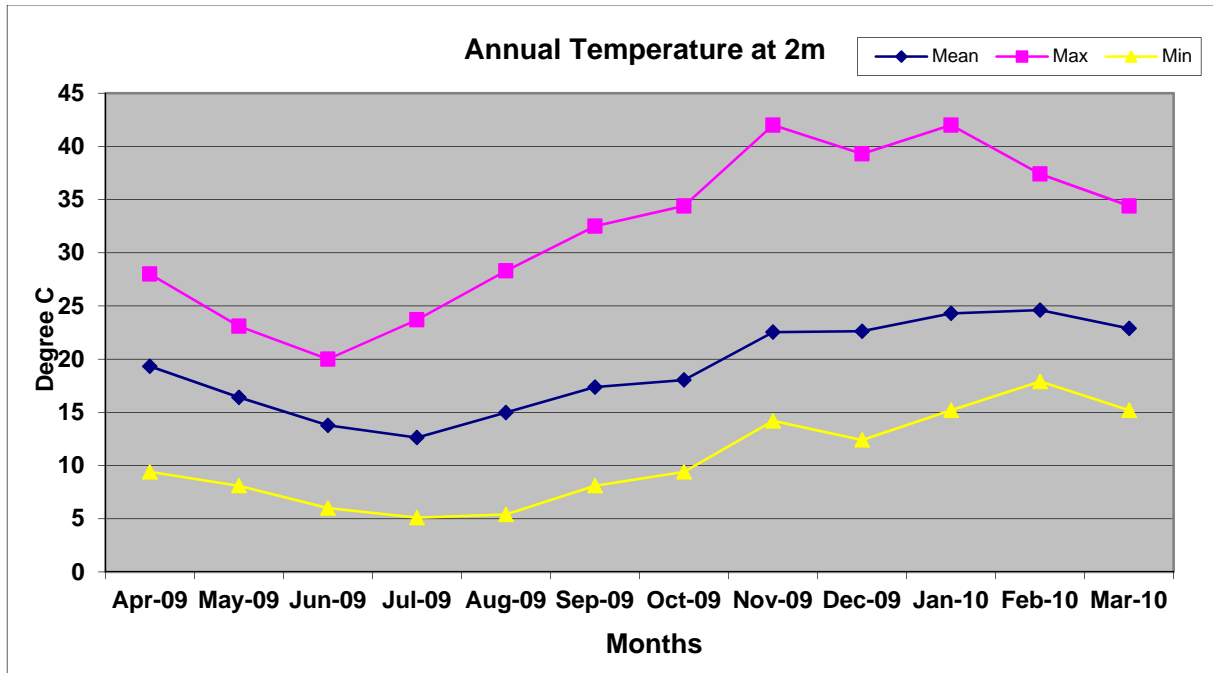
Figure 3.1.2: Average Temperature

The monthly statistical information for each of the meteorological monitoring parameters is detailed in Table 3.1.2. From this information Figure 3.1.2 illustrates the variation in average temperature during the reporting period. These variations from the winter to summer seasons are the expected seasonal norms.

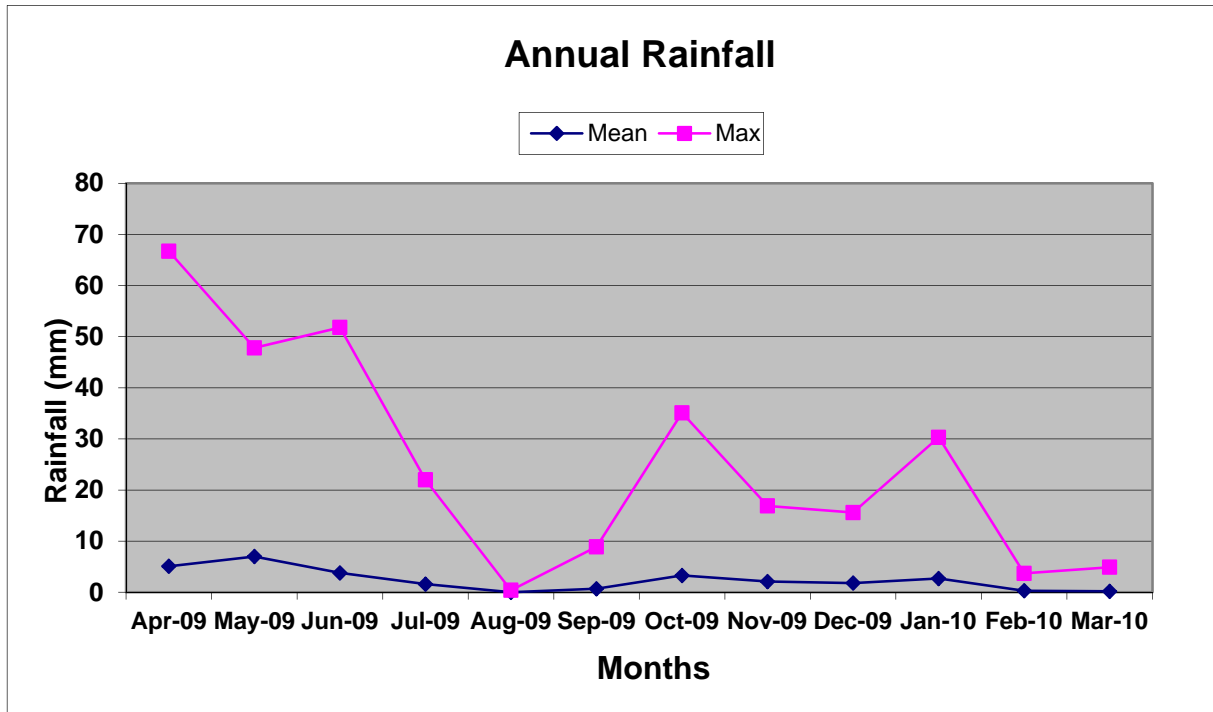
Figure 3.1.3: Daily and Average Rainfall

The daily rainfall recorded at the project site is illustrated by Figure 3.1.3. A total of 874mm of rain was received on the site during the reporting period with the highest rainfall events recorded in the April 2009 to June 2009 period. Relatively low rainfall was also received during the August to September 2009 period and the February to March 2010 period

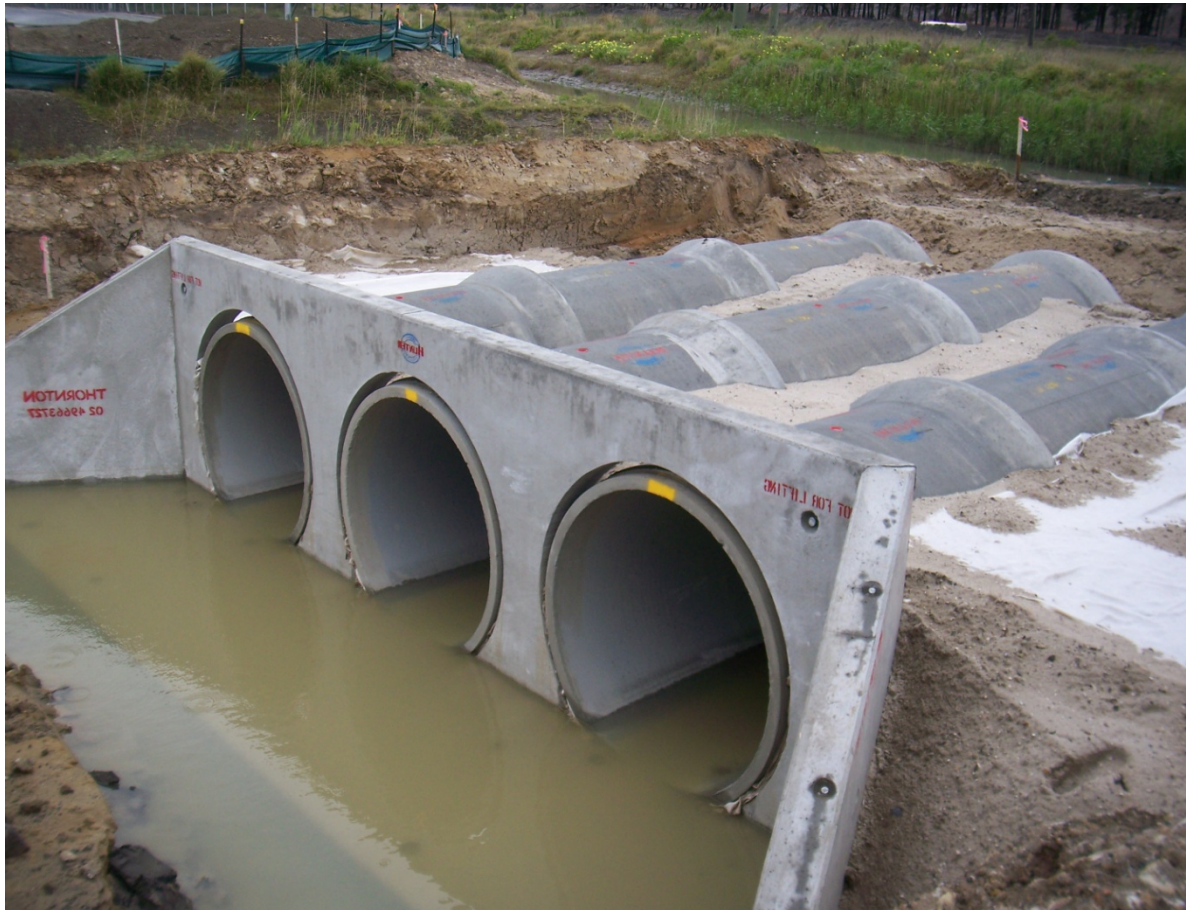
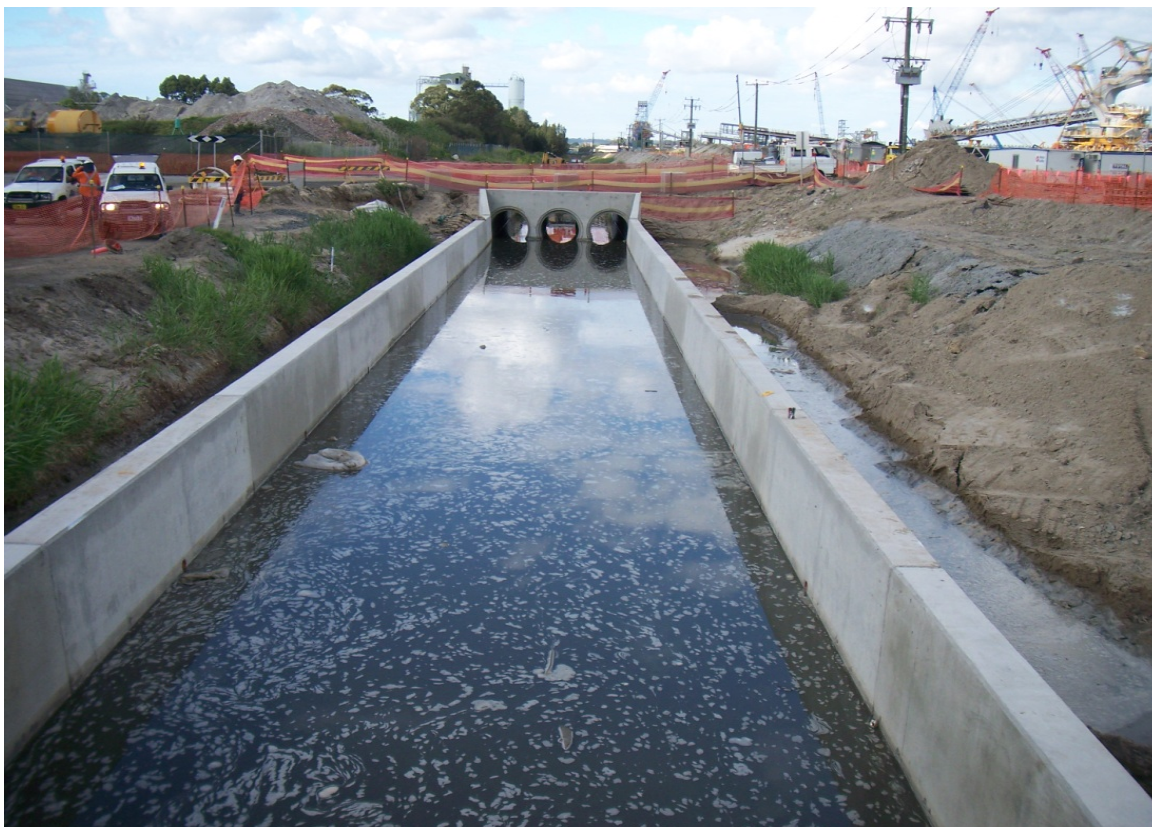
Figure 3.4.1: Construction of Stormwater Infrastructure

A network of permanent stormwater structures has been partially construction to manage runoff around the site. All long-term site water management structures are lined with low permeability materials (e.g. compacted clay) to minimise the potential for leakage. Water management structures are designed with sufficient capacity for a 1 in 100 year average recurrence interval (ARI) rainfall event. The construction of these structures was close to completion at the end of this reporting period as illustrated by Figures 3.4.1 and 3.4.2.

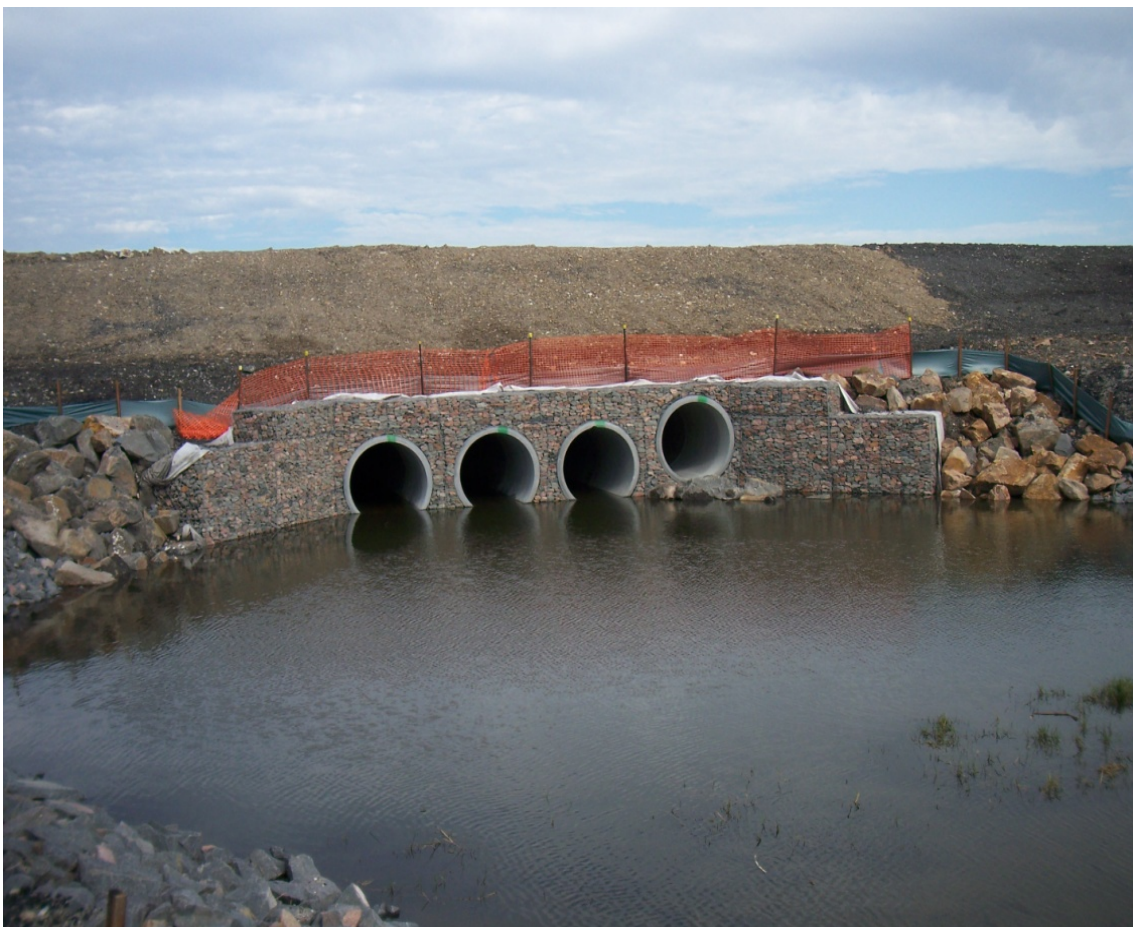
Figure 3.10.2: Installed Rail Culverts for Green and Golden Bell Frog Movement

In accordance with Condition 2.17, Schedule 2 of the Project Approval (06_0009) NCIG has designed and constructed relevant rail infrastructure associated with the Project to include culverts, underpasses or other similar measures to permit the movement of *Litoria aurea* and other amphibian species under the NCIG rail infrastructure (see Figure 3.10.2). The culverts and underpasses were installed to include suitable habitat for the Green and Golden Bell Frogs and to provide protection from predators in accordance with guidance provided by Dr Arthur White.
