NEWCASTLE COAL INFRASTRUCTURE GROUP
COAL EXPORT TERMINAL

ANNUAL ENVIRONMENTAL MANAGEMENT REPORT
2011

November 2011

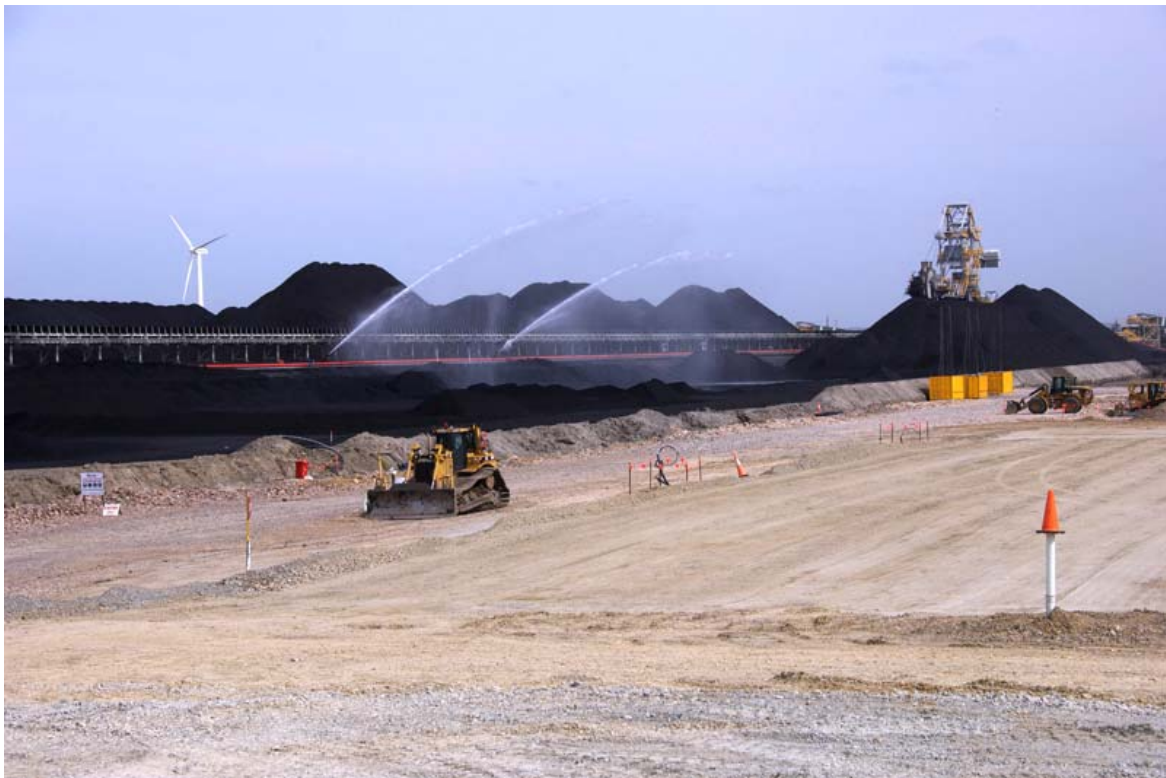
Figure 2.6: Coal Stockyard Dust Suppression Sprays

The rail unloading facility (Figures 2.5 and 2.9), stockyard (Figures 2.8 and 2.11) and wharf (Figures 2.7 and 2.10) facilities were fully operation during the period. A number of NCIG environmental management systems were also in operation during the period. These include the NCIG real-time dust monitoring network (Figure 2.4), consisting of four Environmental Beta Attenuation Monitors (EBAMs) located at the boundaries of the stockyard, and the stockyard dust suppression system (Figure 2.6).

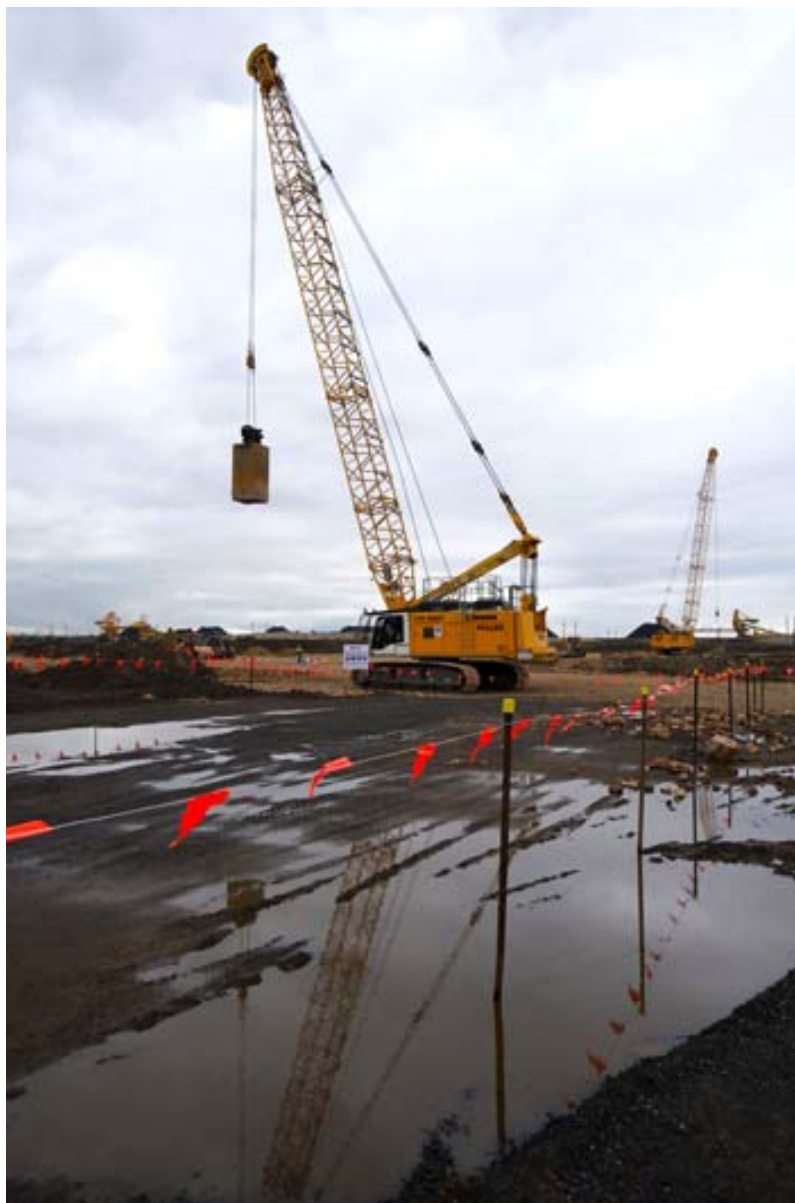
Figure 2.16: Dynamic Replacement

- SR3 Berm construction (Figure 2.14)
- Stage 2AA ground improvement works (dynamic replacement and soil mixing) (Figures 2.16 and 2.18).
- Supply of material for dynamic replacement (Figure 2.23)

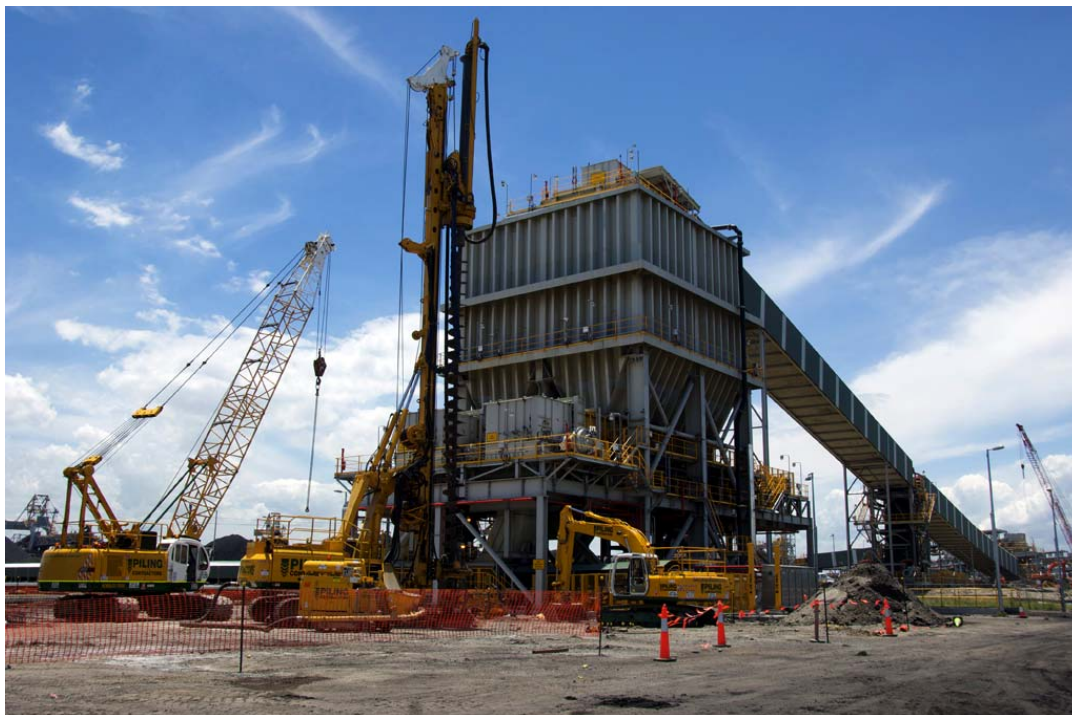
Figure 2.22: Piling for Buffer Bin 2

- Delivery of viaduct panels and planks.
- Piling for conveyors 6, 7, 13, 22 and Buffer Bin 2 (Figure 2.22).
- Inbound and outbound structural and mechanical installations.

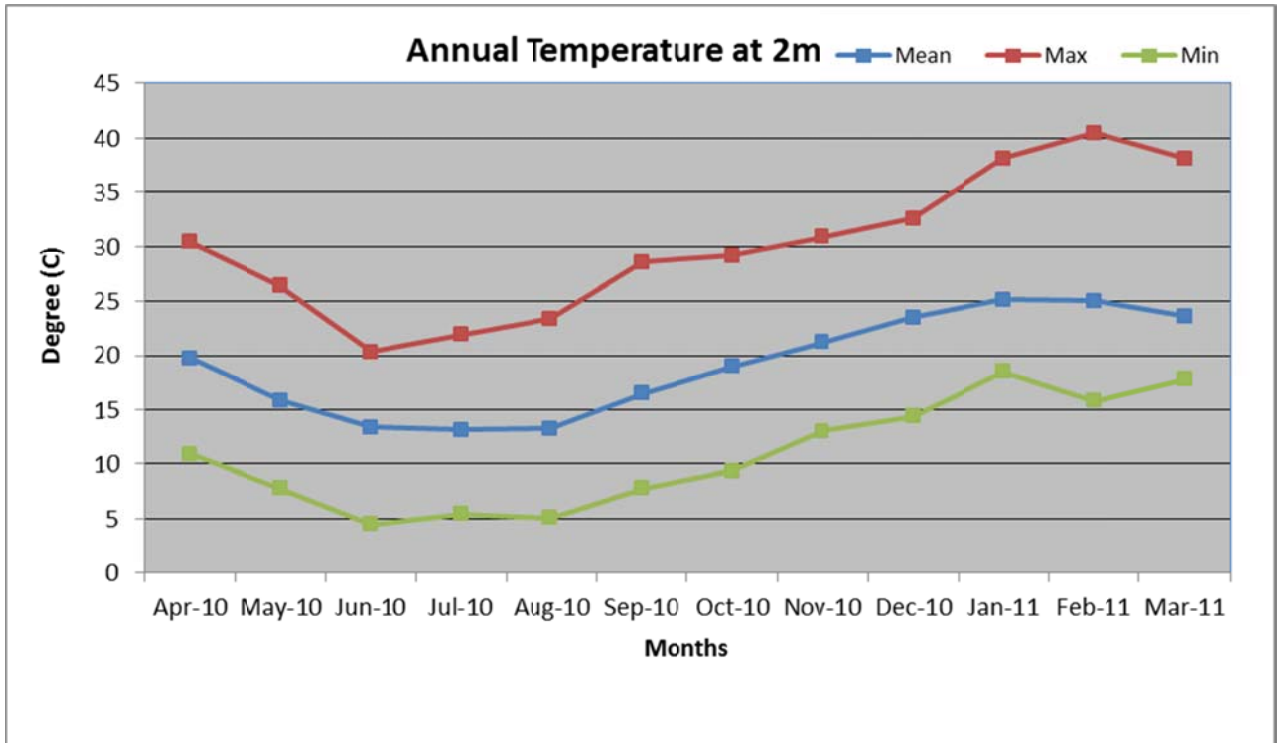
Figure 3.1.2: Average Temperature

The monthly statistical information for each of the meteorological monitoring parameters is detailed in Table 3.1.2. From this information Figure 3.1.2 illustrates the variation in average temperature during the reporting period. These variations from the winter to summer seasons are the expected seasonal norms.

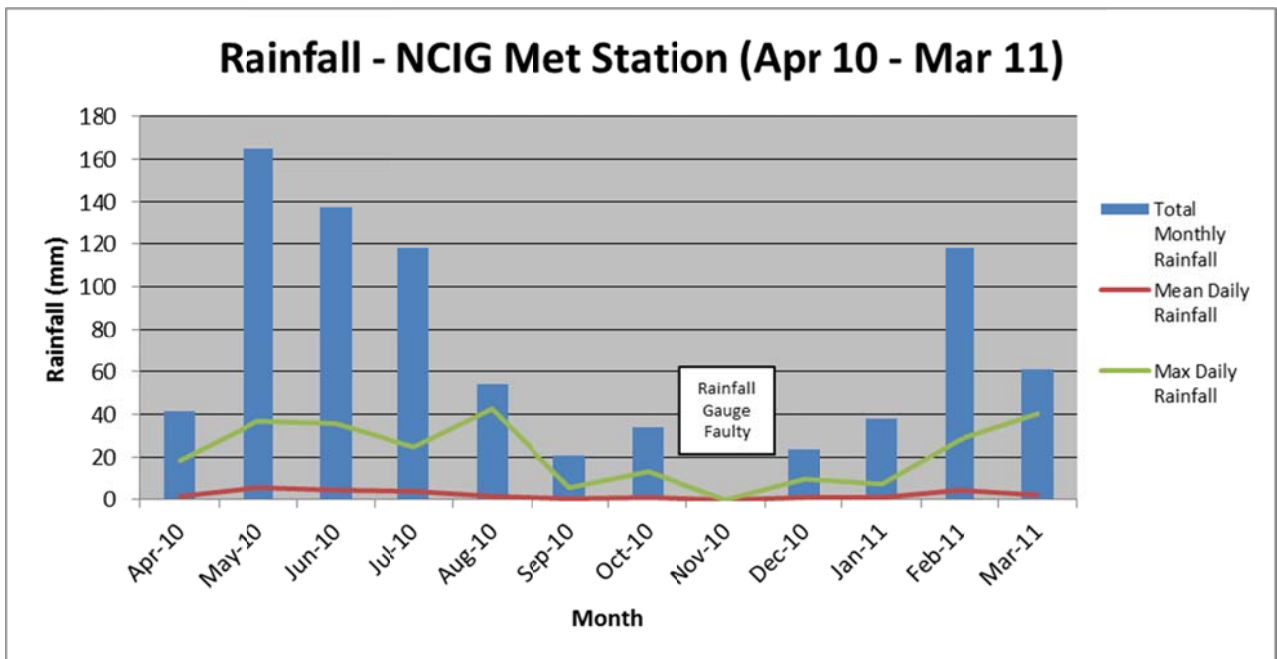
Figure 3.1.3: Daily and Average Rainfall

The daily rainfall recorded at the project site is illustrated by Figure 3.1.3. A total of 874mm of rain was received on the site during the reporting period with the highest rainfall events recorded in the May 2010 to July 2010 period. Relatively low rainfall was also received during the August 2010 to January 2011 period

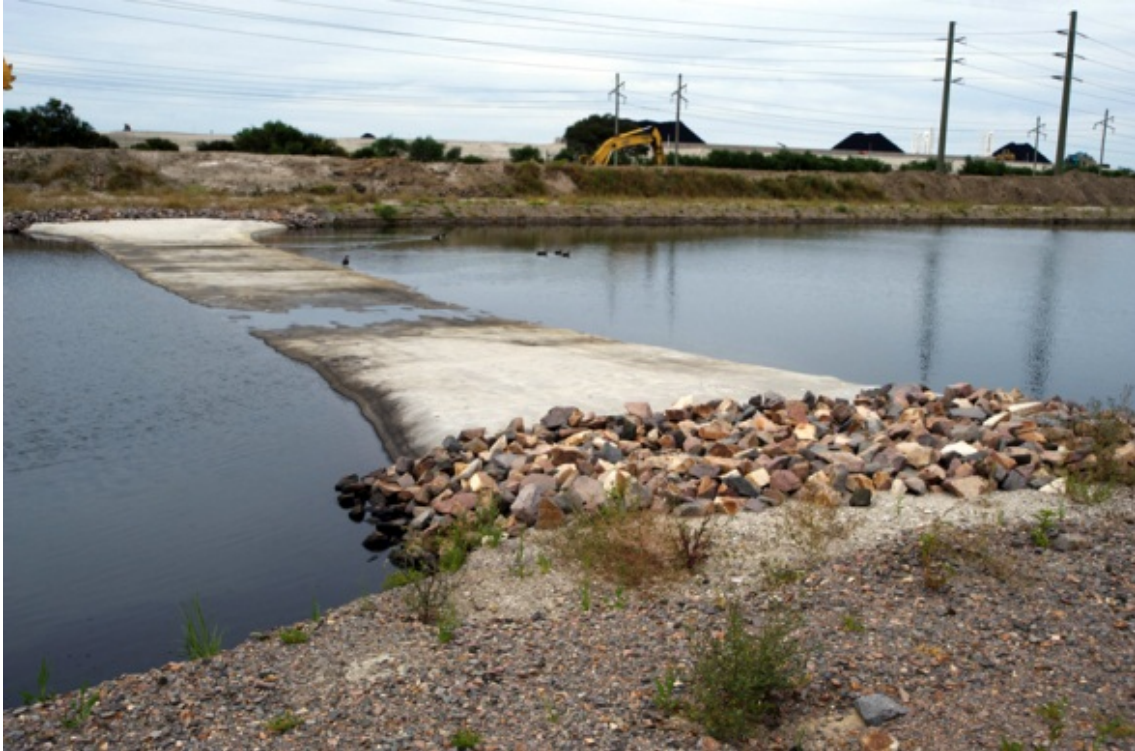
Figure 3.4.1: Settling Pond Infrastructure

A network of permanent stormwater structures has been constructed to manage runoff around the site. All long-term site water management structures are lined with low permeability materials (e.g. compacted clay) to minimise the potential for leakage. Water management structures are designed with sufficient capacity for a 1 in 100 year average recurrence interval (ARI) rainfall event. The majority of these structures, particularly the settling pond system, were completed during this reporting period as illustrated by Figures 3.4.1. Figure 3.4.2 illustrates completion of permanent structures, in this case an open V-drain along the Southern Haulage Rd.

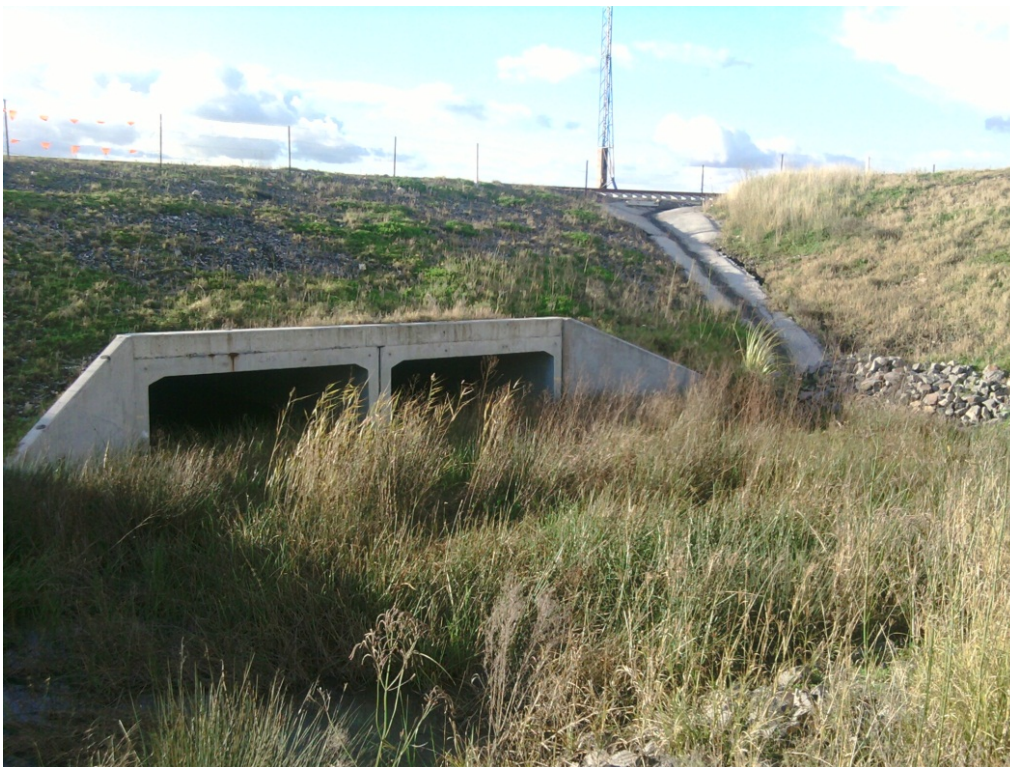
Figure 3.10.2: Installed Rail Culverts for Green and Golden Bell Frog Movement

In accordance with Condition 2.17, Schedule 2 of the Project Approval (06_0009) NCIG has designed and constructed relevant rail infrastructure associated with the Project to include culverts, underpasses or other similar measures to permit the movement of *Litoria aurea* and other amphibian

species under the NCIG rail infrastructure (see Figure 3.10.2). The culverts and underpasses were installed to include suitable habitat for the Green and Golden Bell Frogs and to provide protection from predators in accordance with guidance provided by Dr Arthur White.

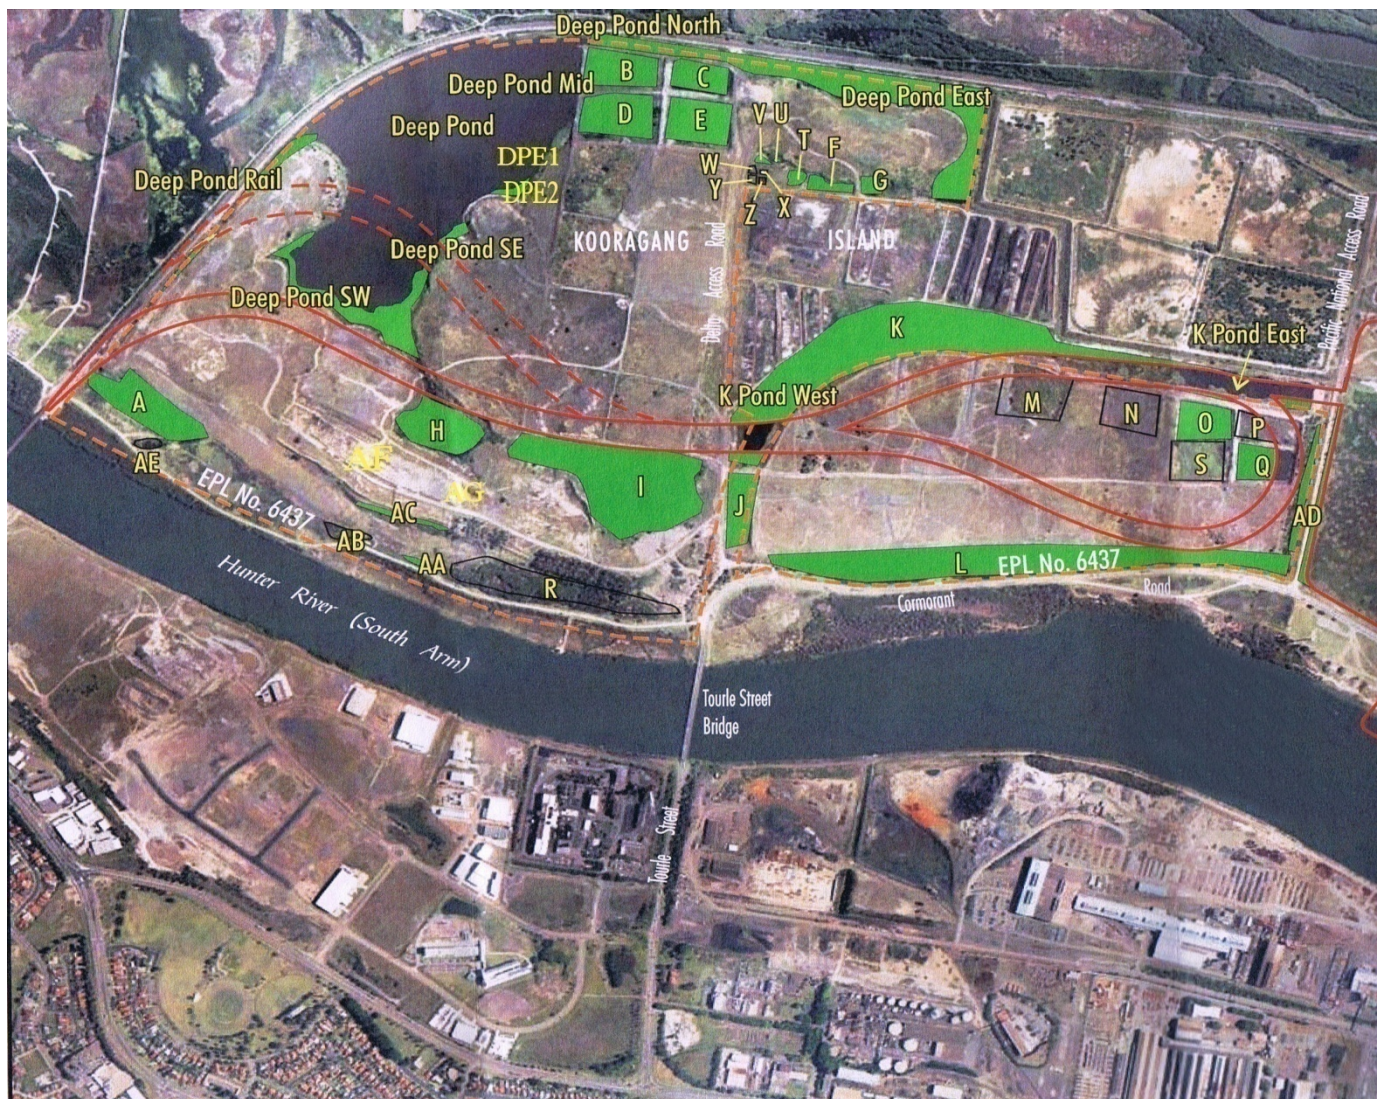
Figure 3.10.3: Green and Golden Bell Frog Habitat Areas.

Known and potential Green and Golden Bell Frog habitat is located across the Project site and surrounds. Disturbance to Green and Golden Bell Frog habitat occurred as a result of construction activities which primarily involved completely infilling Big Pond and partial disturbance of Ponds H, K and Q (see Figure 3.10.3). Most of the known and potential Green and Golden Bell Frog habitat recorded across the Project site and surrounds (i.e. Ponds A, B, C, D, E, F, G, I, J, L, O, T, U, V, AA, AC, AD) has not however been directly disturbed by Project activities.
