NEWCASTLE COAL INFRASTRUCTURE GROUP  
COAL EXPORT TERMINAL

ANNUAL ENVIRONMENTAL MANAGEMENT REPORT  
2012

**December 2012**

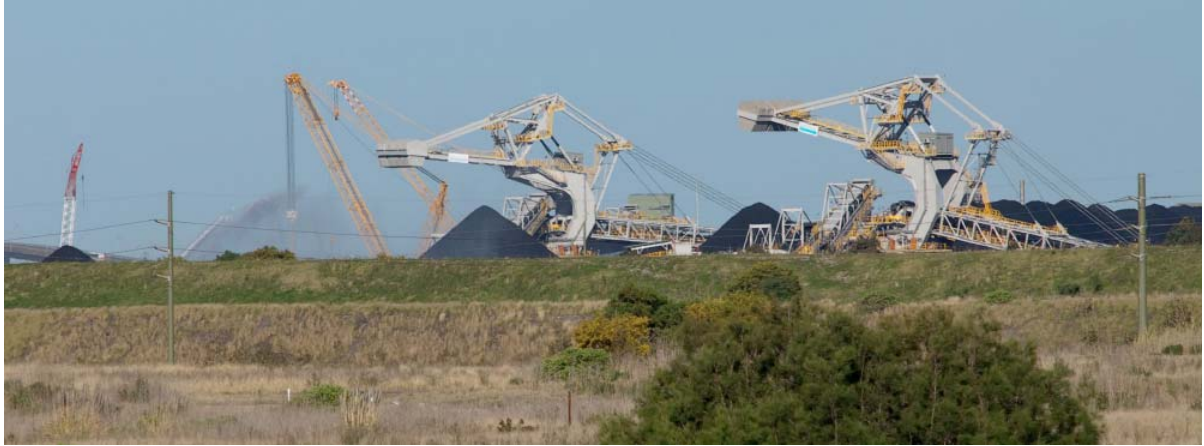
**Figure 2.2: Stockyard Dust Suppression Sprays in operation at NCIG Terminal**

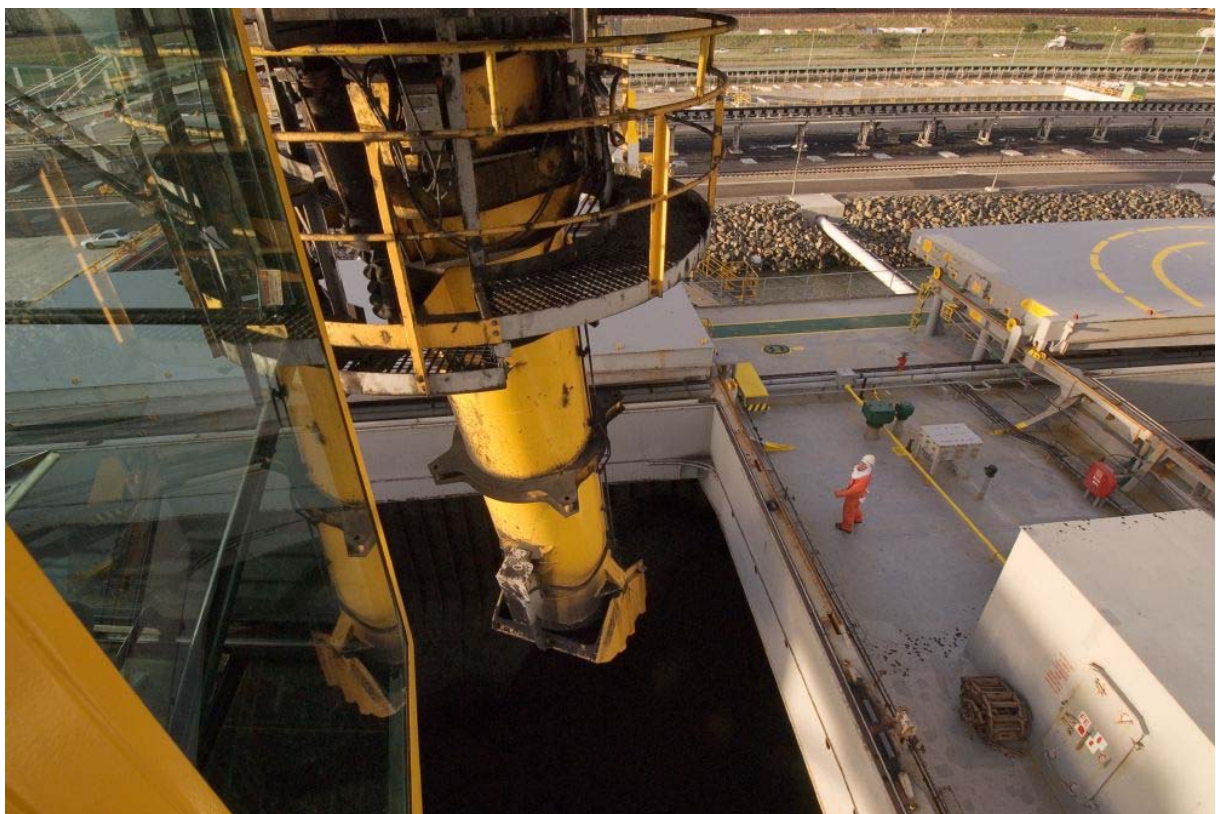
Figure 2.7: Spout of Shiploader 1 in ship hatch

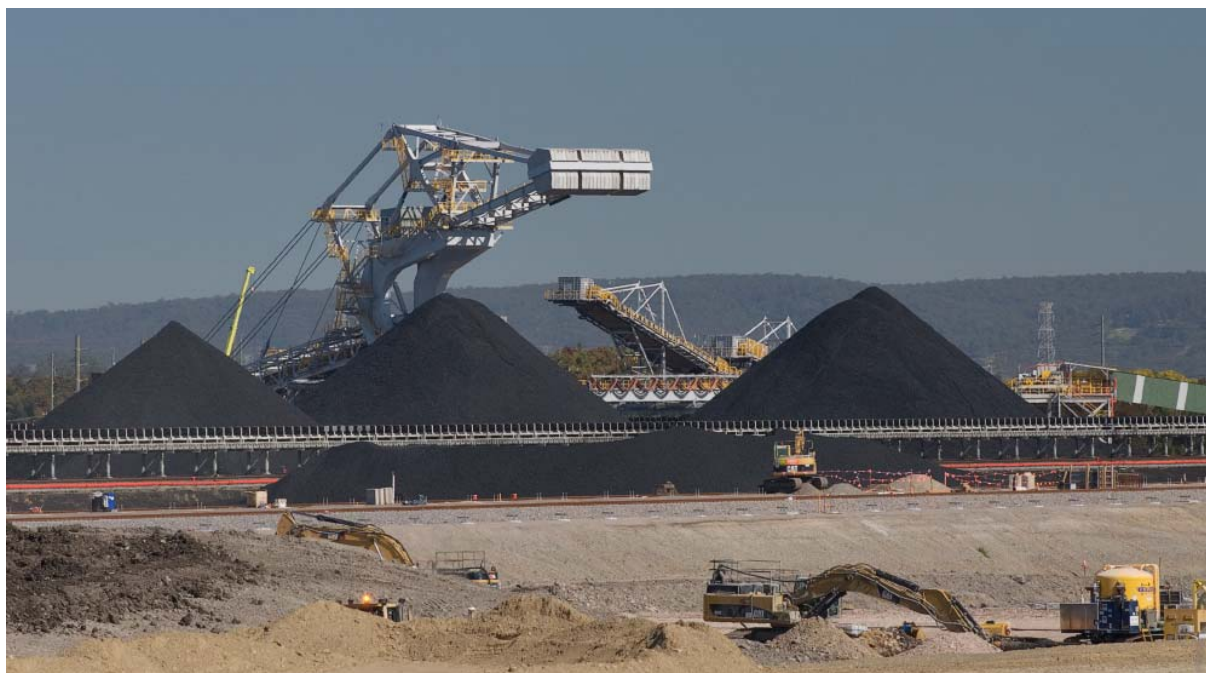
**Figure 2.9: Earthworks for SR03 and Stockpad 4**

- Continuation of Stage 2AA ground improvement works (Figure 2.9).
- Supply of material for dynamic replacement.
- Construction, onsite assembly and commissioning of the Shiploader 2 and Stacker/Reclaimer 3 (Figures 2.11, 2.22 and 2.25).

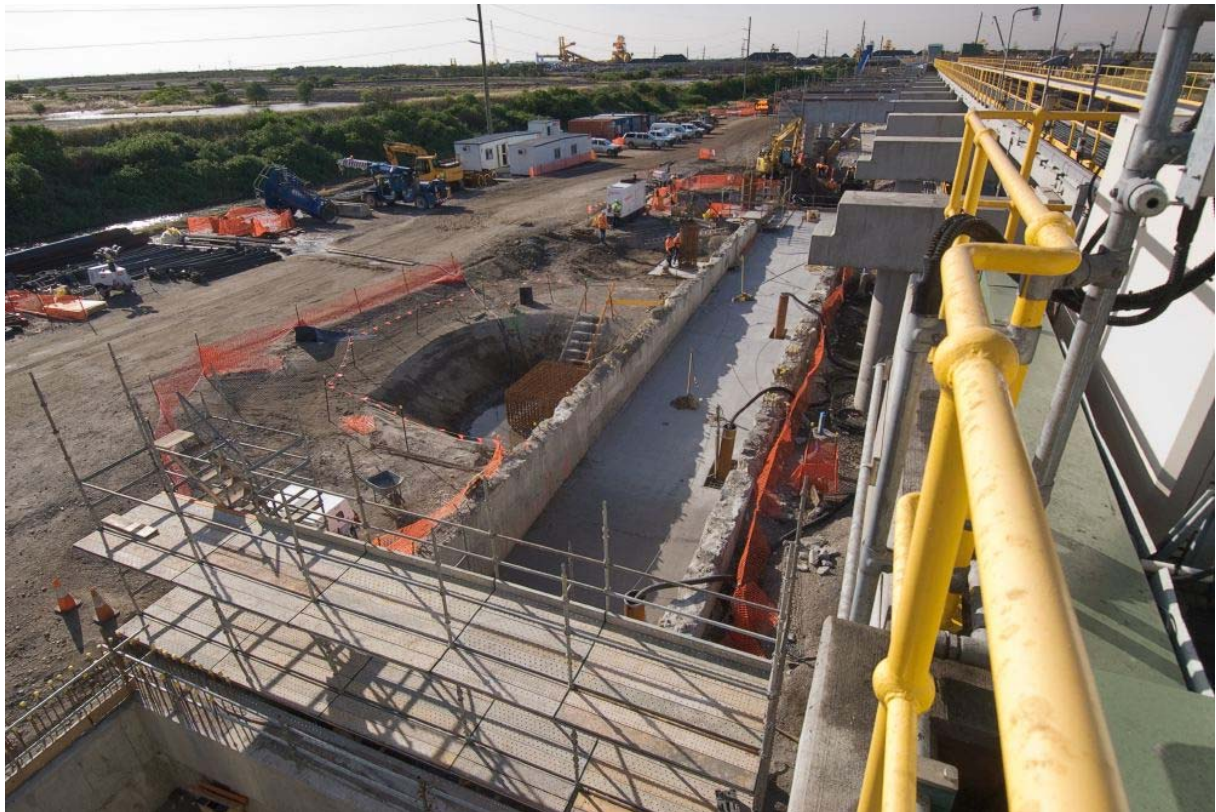
**Figure 2.13: CV02 Tunnel construction, under DS02**

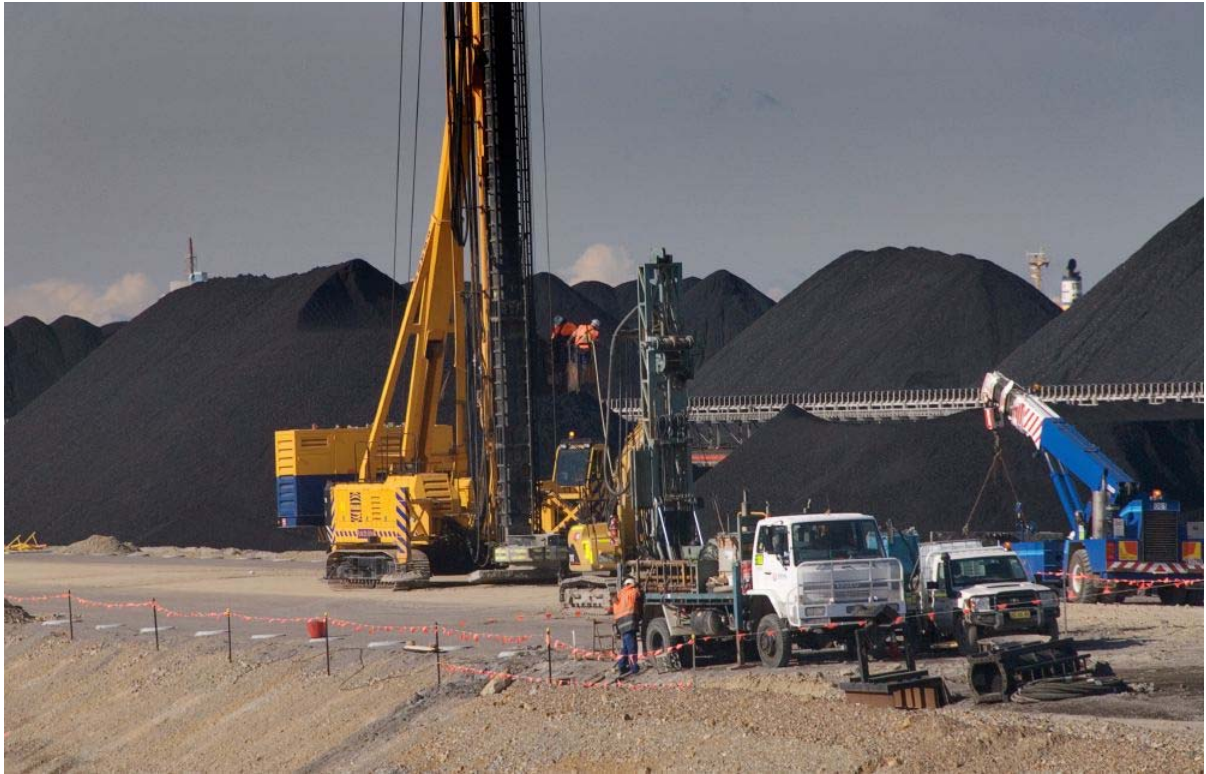
**Figure 2.16: Concrete piling for CV10**

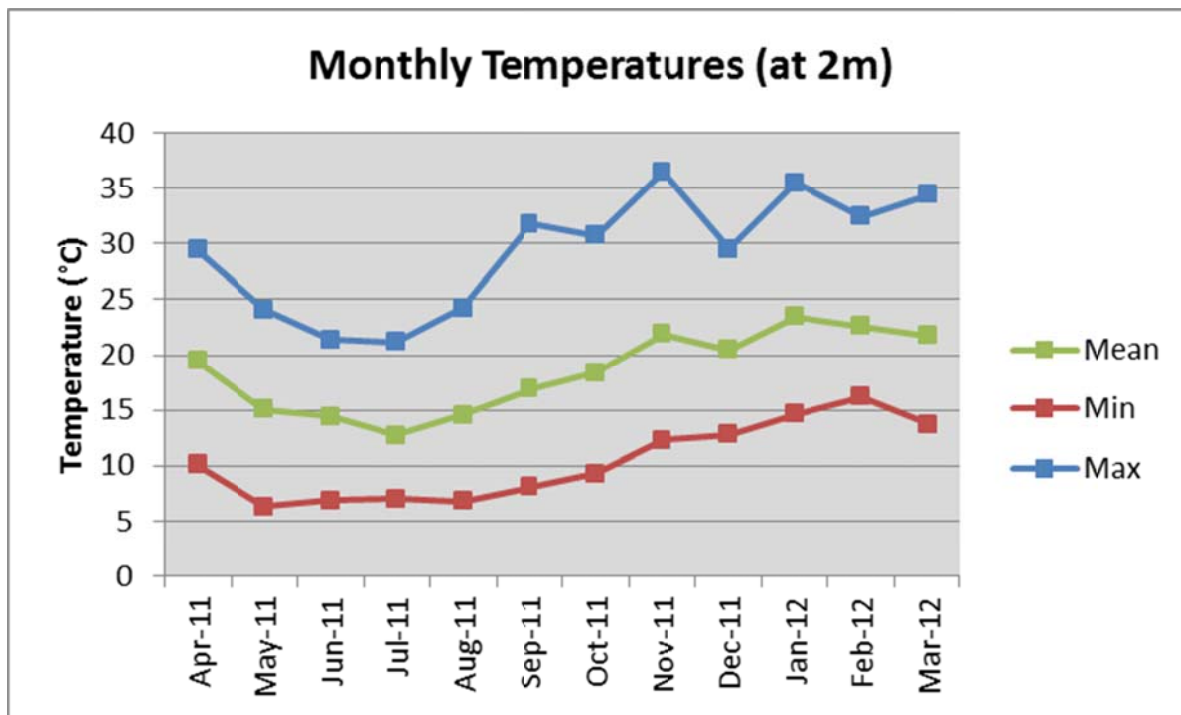
The monthly statistical information for each of the meteorological monitoring parameters is detailed in Table 3.1.2. From this information Figure 3.1.2 illustrates the variation in average temperature during the reporting period. These variations from the winter to summer seasons are the expected seasonal norms.

**Figure 3.1.2: Average Temperature**

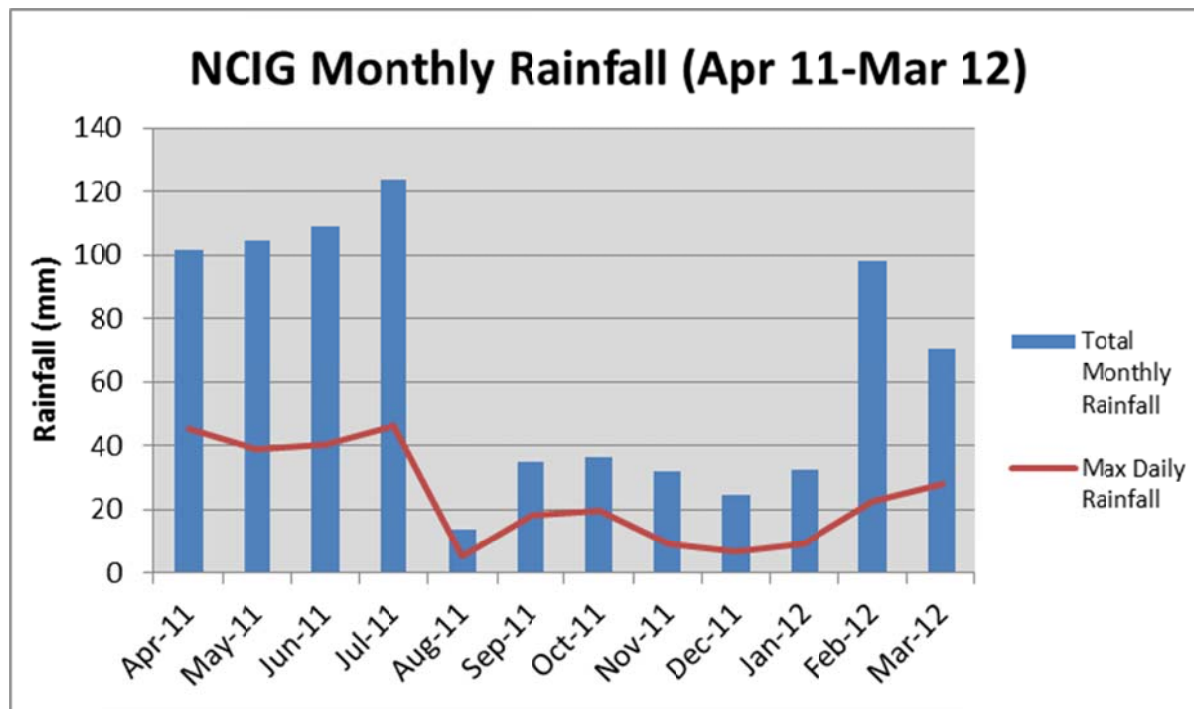
The monthly and daily rainfall recorded at the project site is illustrated by Figure 3.1.3. A total of 781mm of rain was received on the site during the reporting period with the highest rainfall event recorded in July 2011. Low rainfall was received during the August 2011 to January 2012 period.

**Figure 3.1.3: Daily and Average Rainfall**

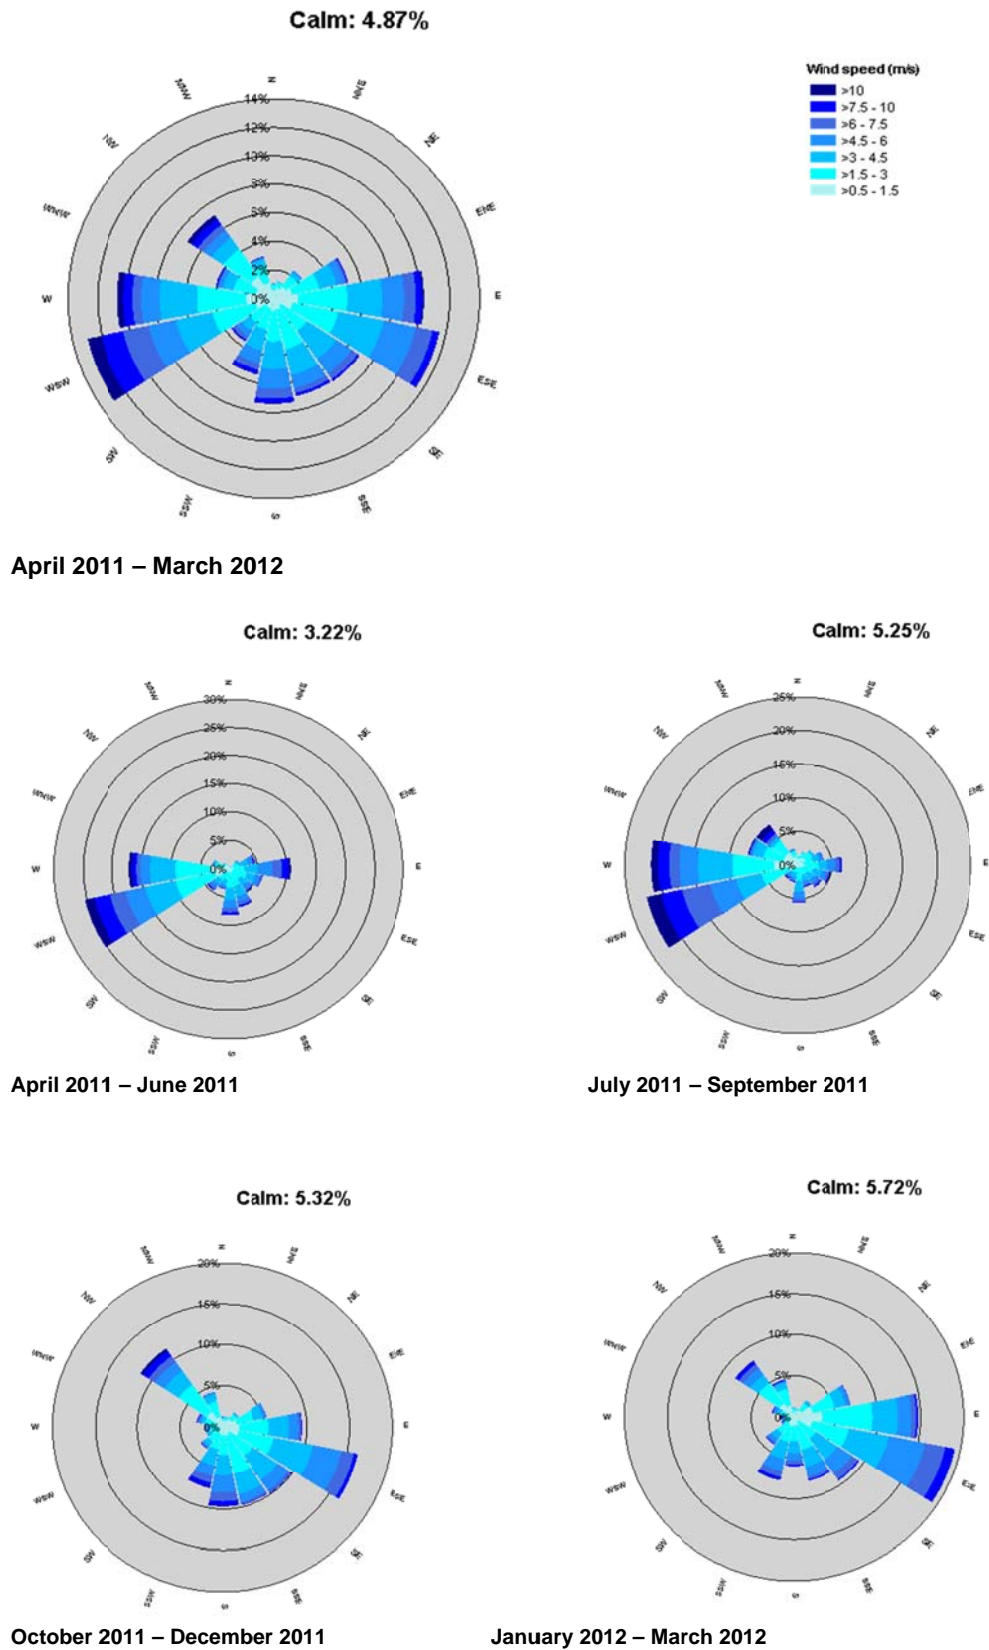
Figure 3.1.4 also illustrates the seasonal variation in wind speed and direction at the site which highlights that the dominant conditions in relation to wind has a westerly aspect during the autumn,

winter and spring periods and has a predominately easterly aspect with some westerlies during the summer period.

**Figure 3.1.4: Seasonal Wind Conditions**

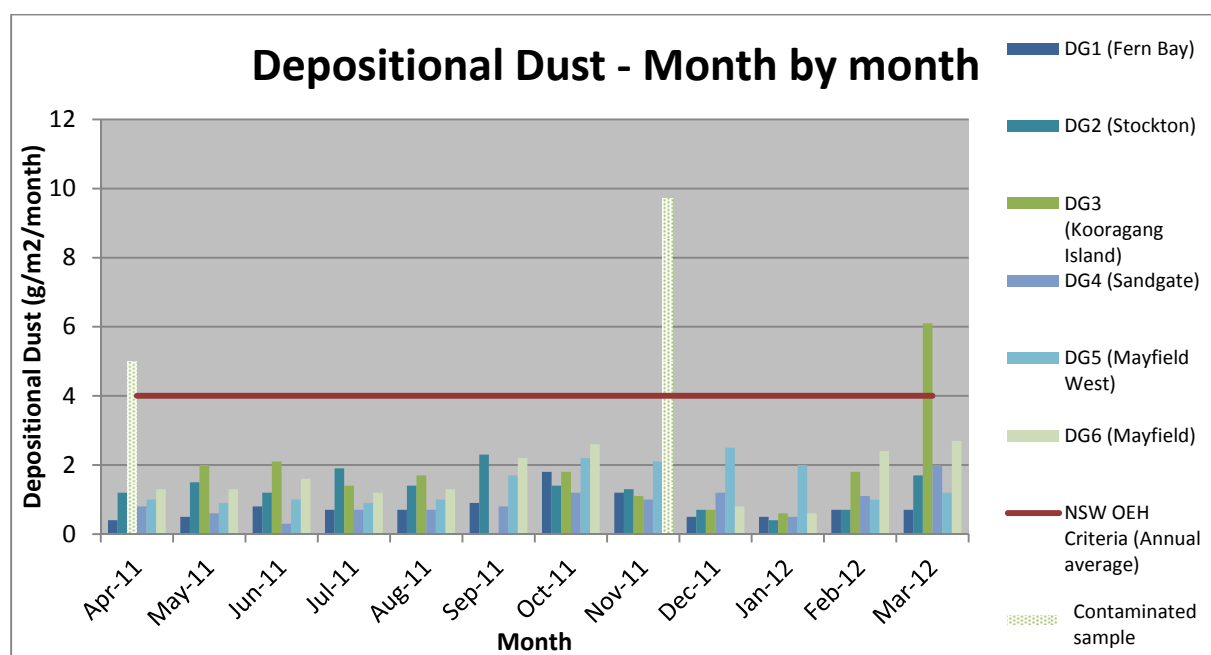
The depositional dust monitoring results for the reporting period are displayed in Figures 3.2.1 and 3.2.2 below.

Figure 3.2.1: Month by Month Depositional Dust

Average depositional dust results were below the monthly criteria of 4 grams per square metre per month at all depositional dust gauge locations (Figure 3.2.2). Figure 3.2.1 shows that DG3 exceeded the 4g/m<sup>2</sup>/month criteria in April 2011 (4.2) and March 2012 (6.1), however this was caused by contaminated samples. DG6 also exceeded the criteria in November (9.7), which was caused by contamination. All other dust gauges were consistently below the criteria. It should be noted that the criteria is specific only to an annual average for each location. Figure 3.2.2 illustrates that the annual average at each location was below 4g/m<sup>2</sup>/month during the reporting period. Full dust deposition data for the reporting period is provided in Attachment A.

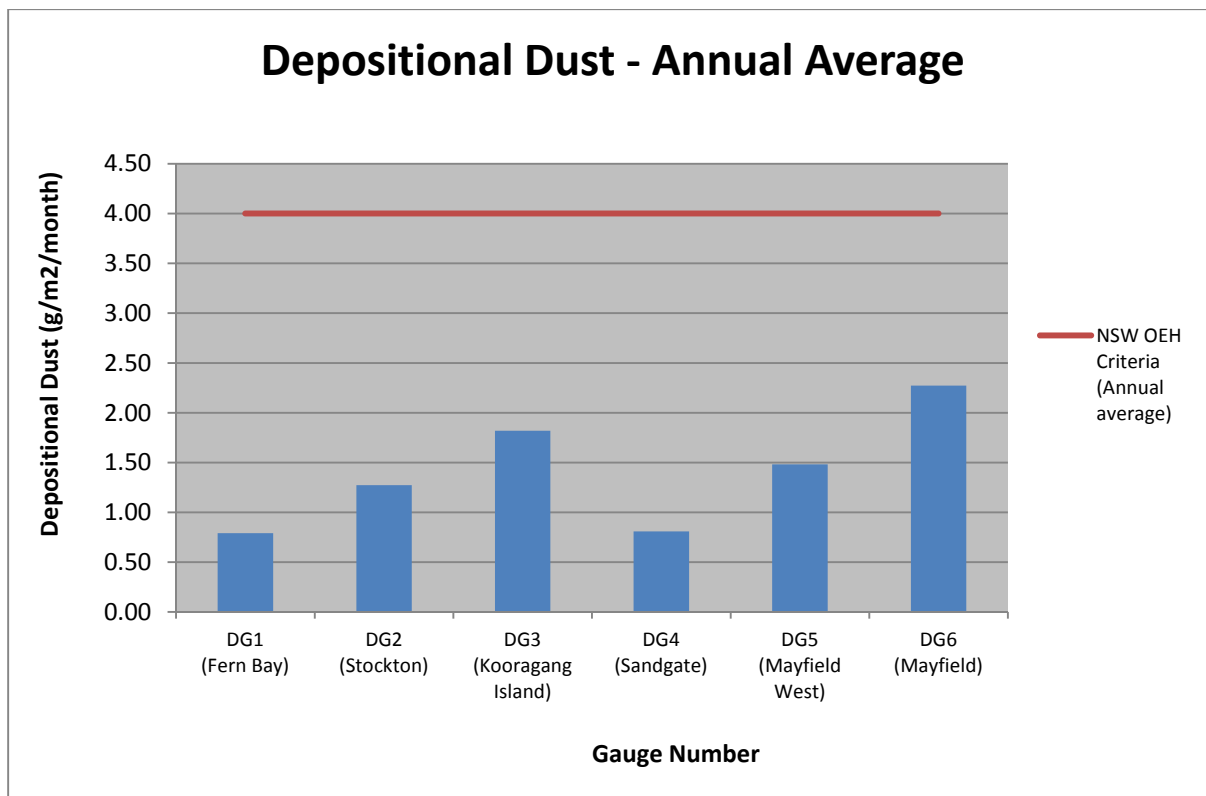
**Figure 3.2.2: Annual Average Depositional Dust**

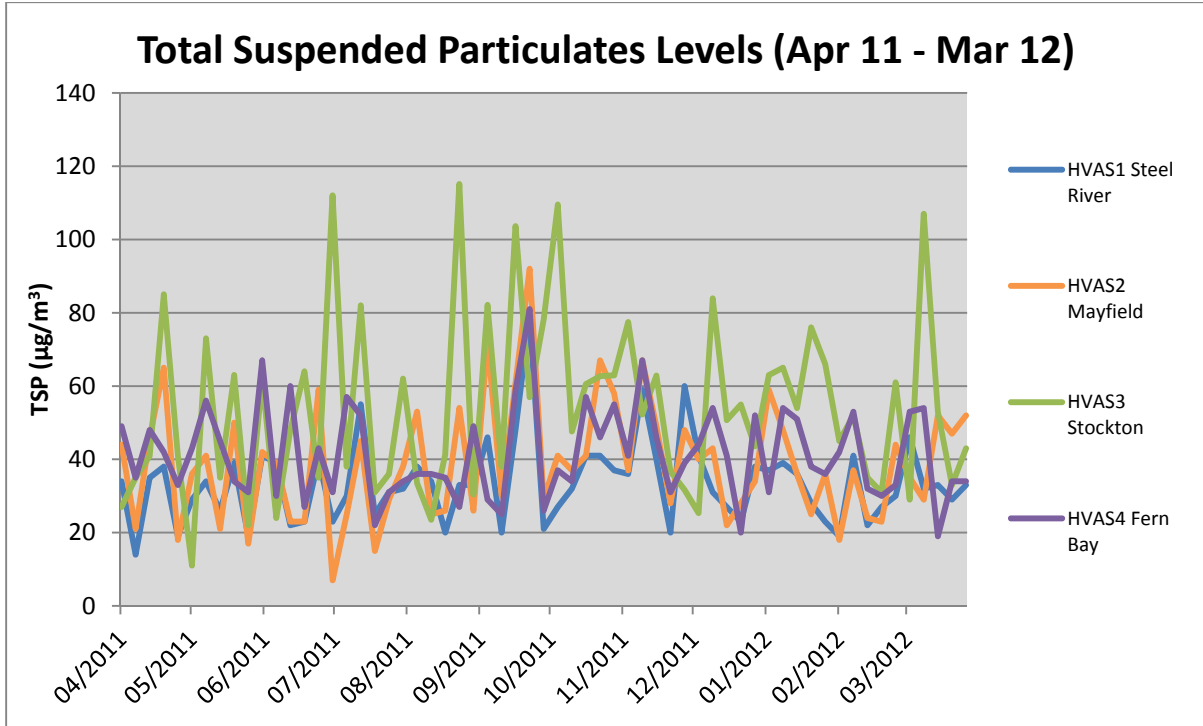
Air quality monitoring results from High Volume Air Sampling (HVAS), as they relate to both Total Suspended Particulate (TSP) and Particulate Matter less than 10 Microns (PM<sub>10</sub>), are displayed in Figures 3.2.3 and 3.2.4.

Figure 3.2.3: Total Suspended Particulates (TSP)

The annual average TSP concentrations for all four monitoring locations were below the NHMRC Annual Average Limit of  $90\mu\text{g}/\text{m}^3$ , as shown in Table 3.2.2. Daily concentrations of  $\text{PM}_{10}$  were also below their respective guideline of  $50\mu\text{g}/\text{m}^3$  (OEH and NEPM), with the exception of three individual dates; 24 August 2011, 5 October 2011 and 9 March 2012 (all Stockton). Meteorological conditions

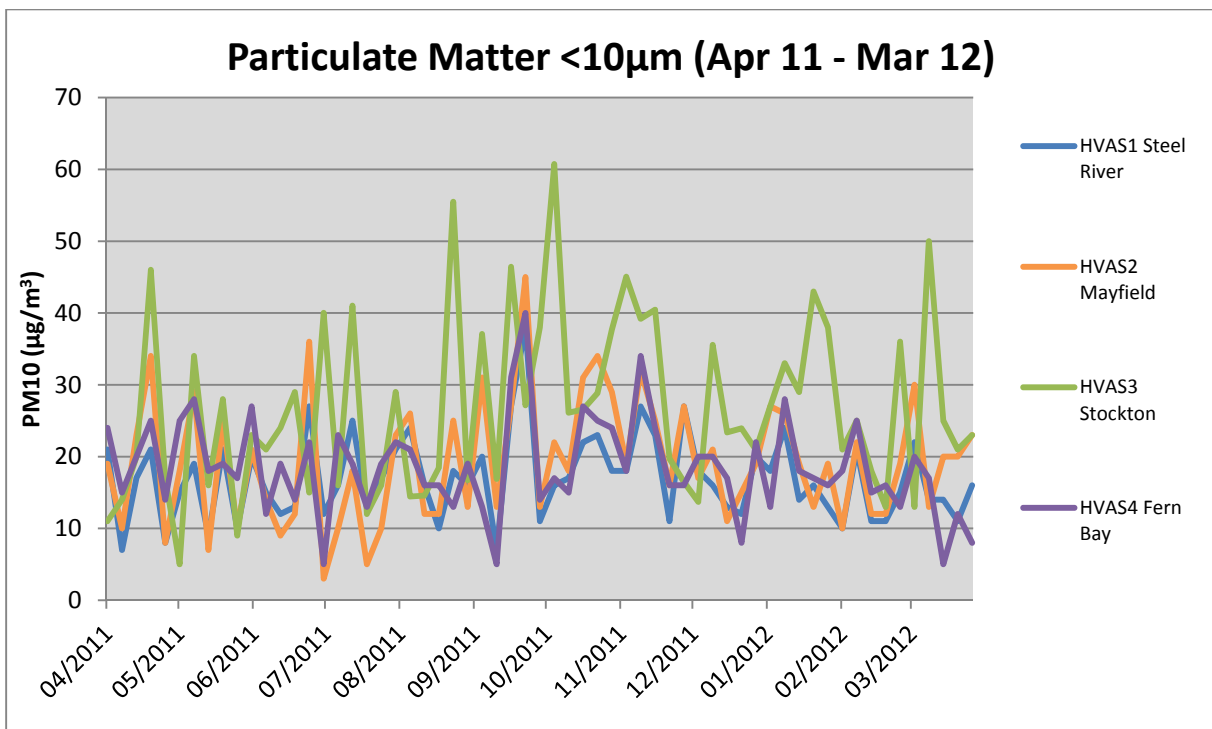
Figure 3.2.4: Particulate Matter <10 $\mu\text{m}$  (PM10)

- 9 March 2012 – 24hr PM<sub>10</sub> level was 50µg/m<sup>3</sup>. Wind direction predominantly from the west/northwest. Wind speed reached 8.7 m/s and was above 5 m/s for an extended period. Onsite dust suppression, including stockyard sprays were fully functional and onsite PM<sub>10</sub> monitoring indicated there were no elevated levels during the period of high winds. Despite high risk wind conditions, onsite dust monitoring suggests that NCIG did not contribute to high PM<sub>10</sub> levels in Stockton.

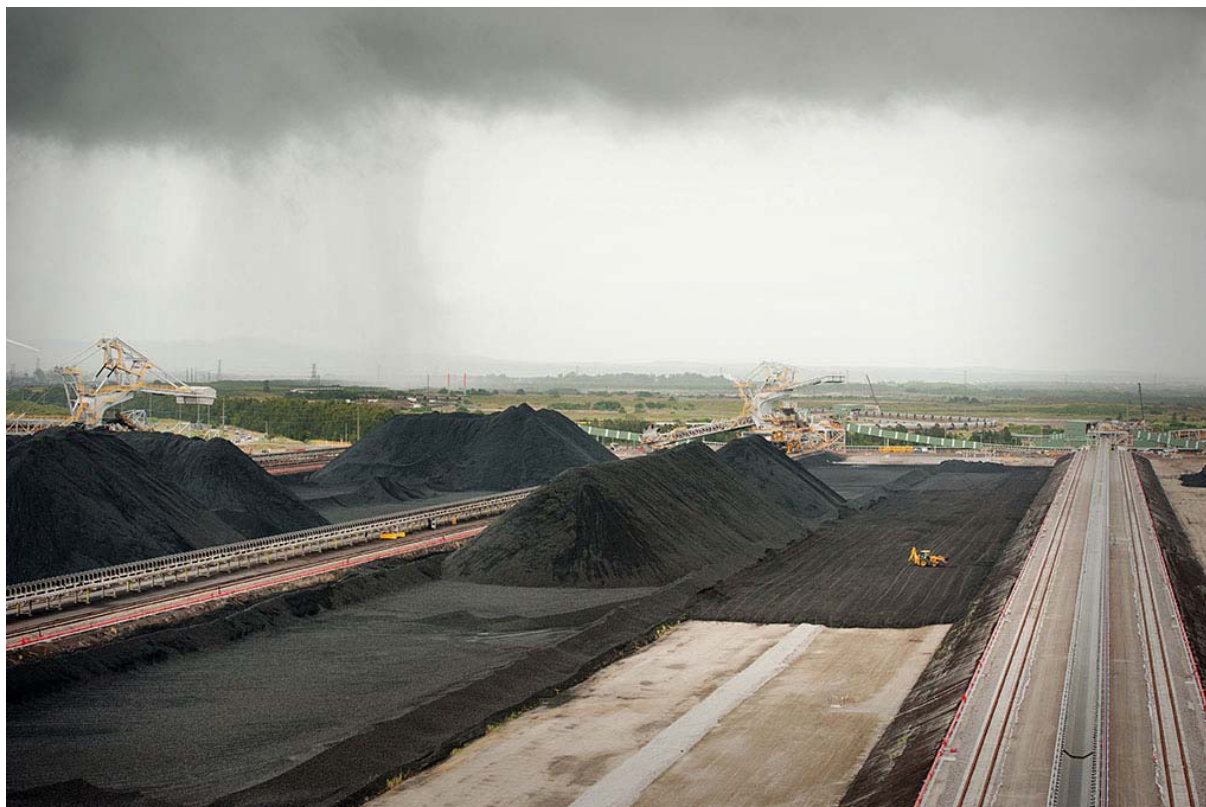
**Figure 3.3.2: Construction of Subsurface Drainage under Stockpile Pad 3**

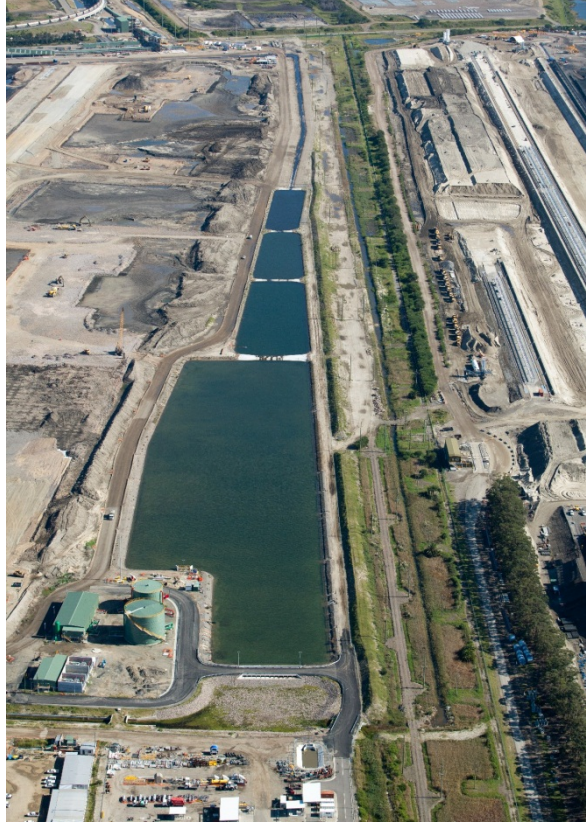
**Figure 3.4.1: Settling Pond Infrastructure**

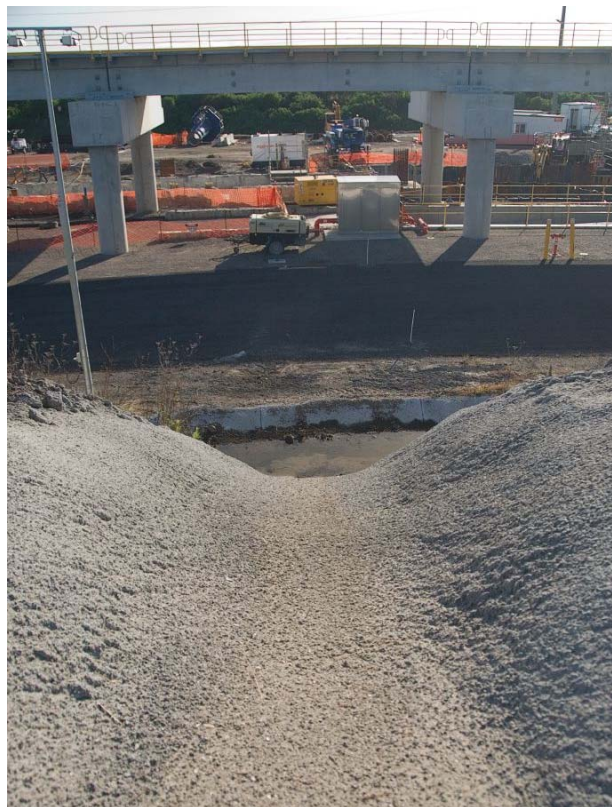
**Figure 3.4.2: Concrete-lined drain leading to Concrete-lined Water Management Pond**

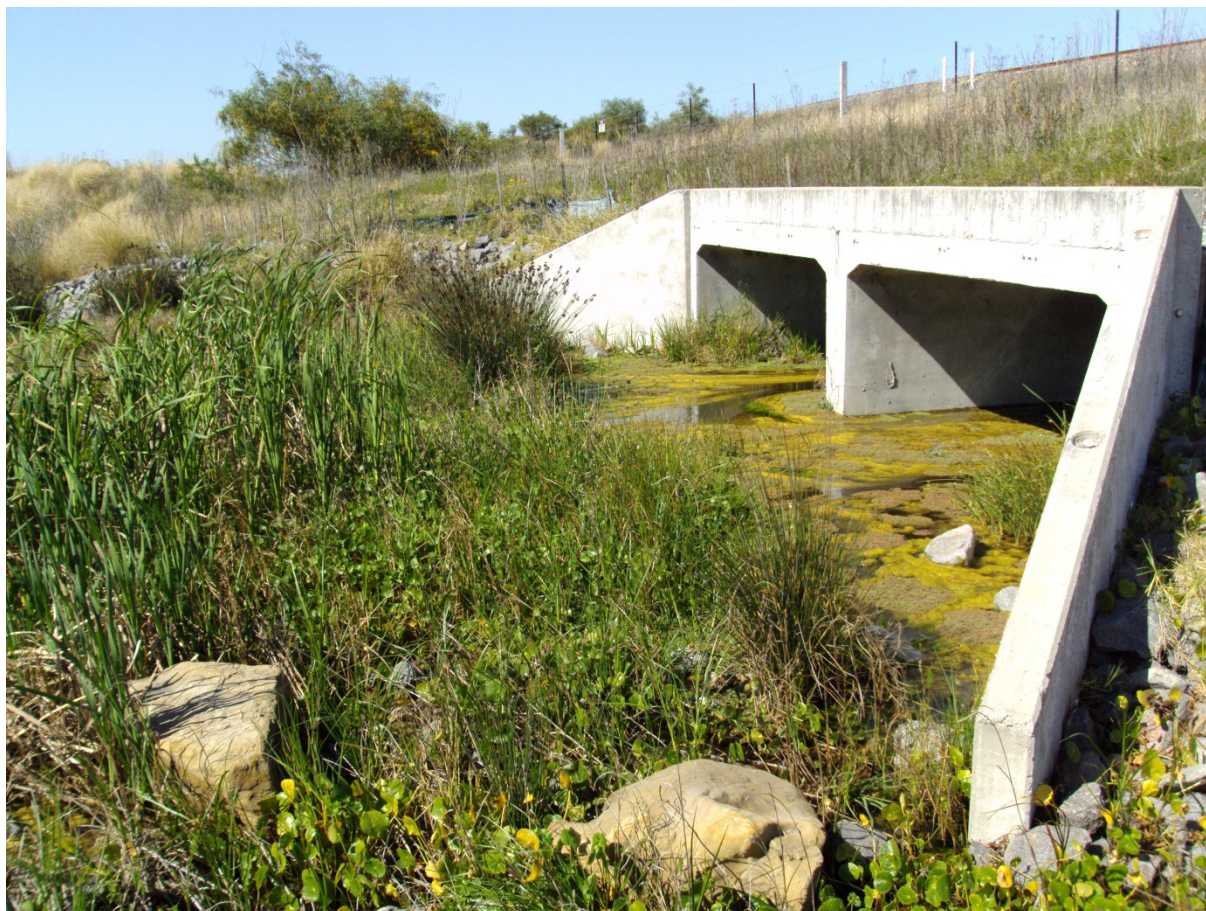
**Figure 3.10.2: Amphibian underpass of rail infrastructure**

In accordance with Condition 2.17, Schedule 2 of the Project Approval (06\_0009) NCIG has designed and constructed relevant rail infrastructure associated with the Project to include culverts, underpasses or other similar measures to permit the movement of *Litoria aurea* and other amphibian species under the NCIG rail infrastructure (see Figure 3.10.2). The culverts and underpasses were installed to include suitable habitat for the Green and Golden Bell Frogs and to provide protection from predators in accordance with guidance provided by Dr Arthur White.
