Document type
Report

Date
October 2015

ANNUAL ENVIRONMENTAL MONITORING REPORT 2015 NCIG COAL EXPORT TERMINAL

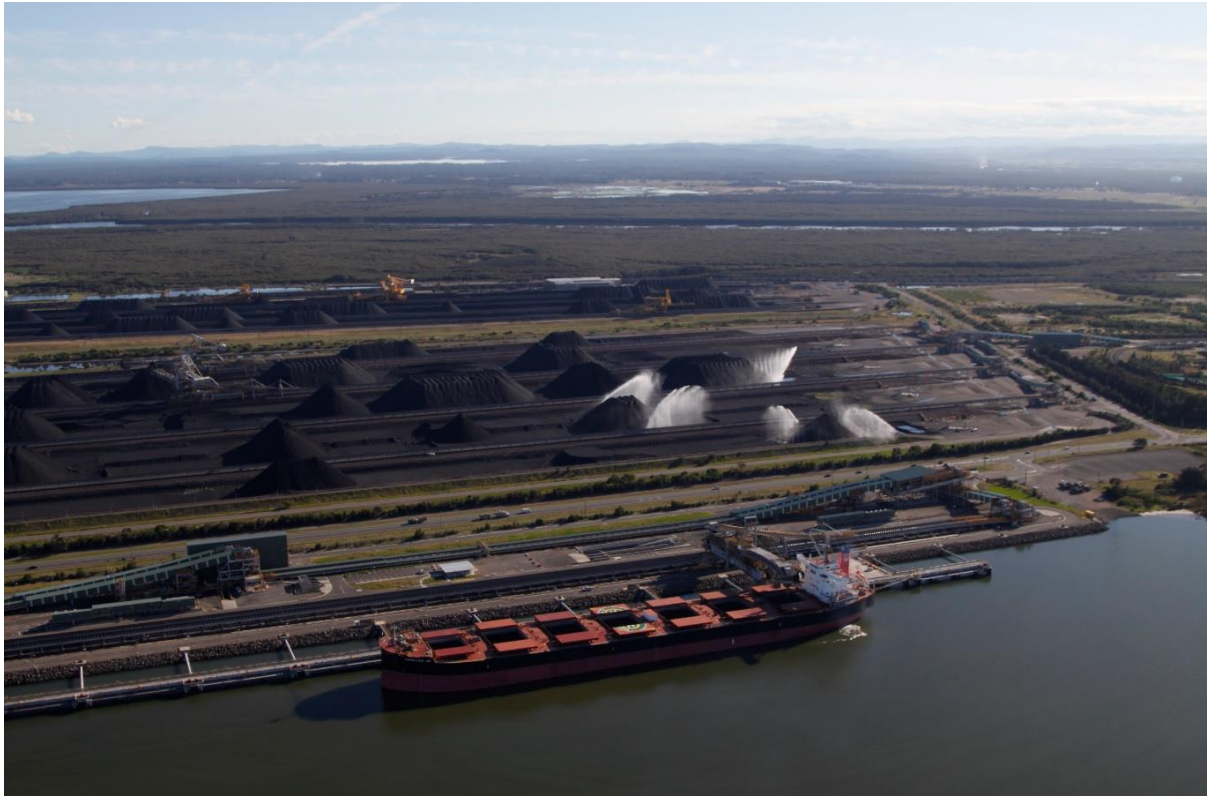
Figure 6: Stockyard with Dust Suppression System

The automated meteorological monitoring station allows parameters such as wind direction to be used in the control of stockyard sprays. This includes activation of sprays based on evaporation of surface moisture from the coal stockpiles and deactivation of sprays under wind conditions where sprays would otherwise be ineffective in reaching coal stockpiles.

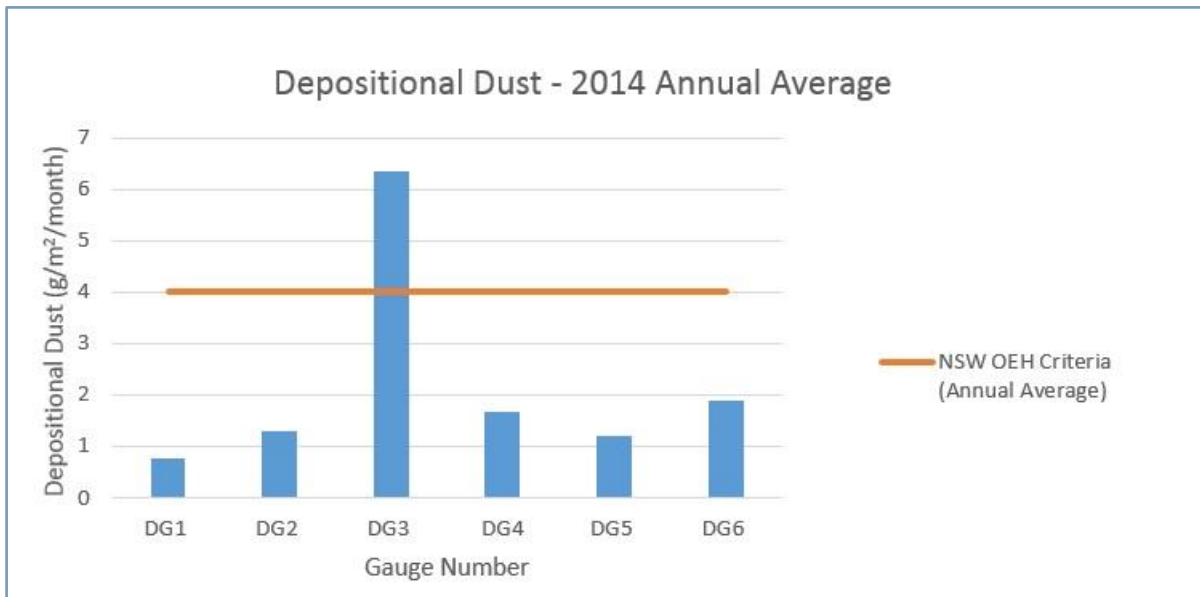
Figure 28: Annual Average Depositional Dust

Average depositional dust results were below the monthly criteria of 4 grams per square metre per month at all depositional dust gauge locations aside from DG3 located at Kooragang Island (Figure 28).

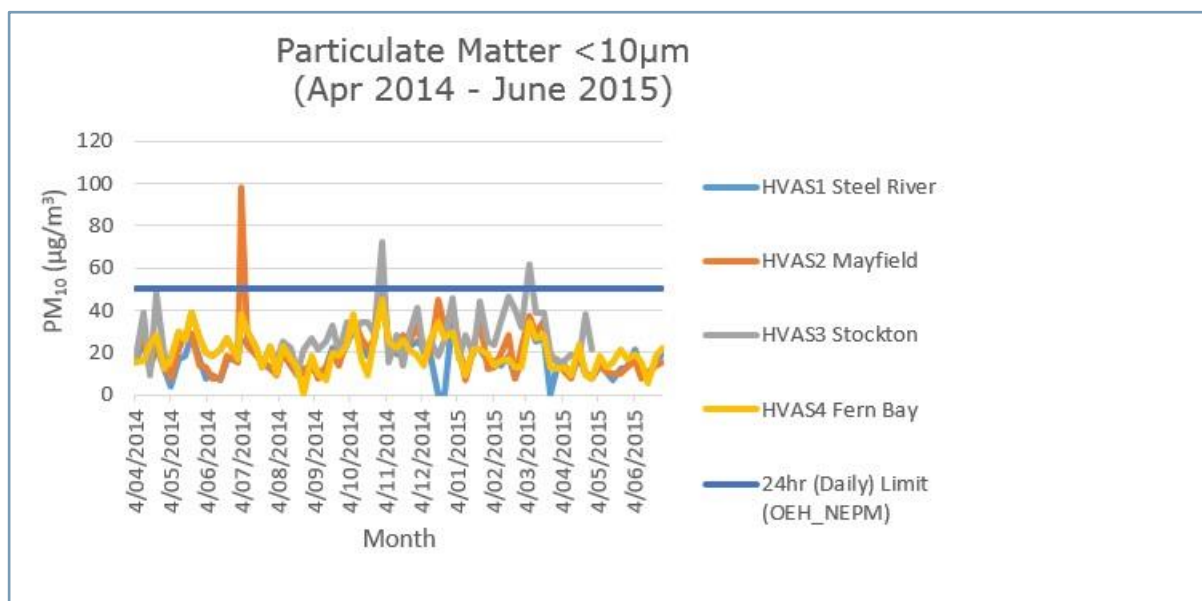
Figure 30: Particulate matter <10µm (PM10)

Daily concentrations of PM₁₀ were also below their respective guideline of 50µg/m³ (OEH and NEPM), with the exception of HVAS2 in Mayfield on 3 July 2014, HVAS2 and HVAS3 in Stockton on 31 October 2014, and HVAS3 on 6 March 2015. Meteorological conditions were reviewed on these days to assess the likelihood that NCIG had contributed to these elevated levels as shown in Table 5 below.

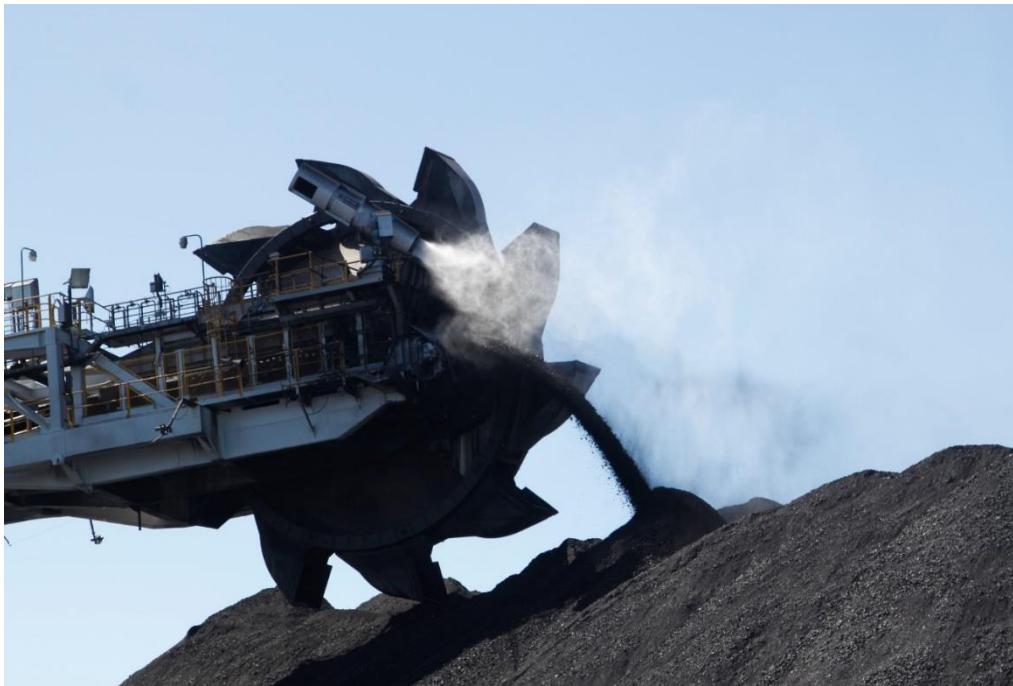
Figure 31: Trial of Fog Cannon

In addition, NCIG trialled a "Fog Cannon" during the reporting period to control dust from stacking and reclaiming operations. A photograph of the "Fog Cannon" is provided in Figure 31. Conclusions on the effectiveness of the cannon will be made in the following reporting period.

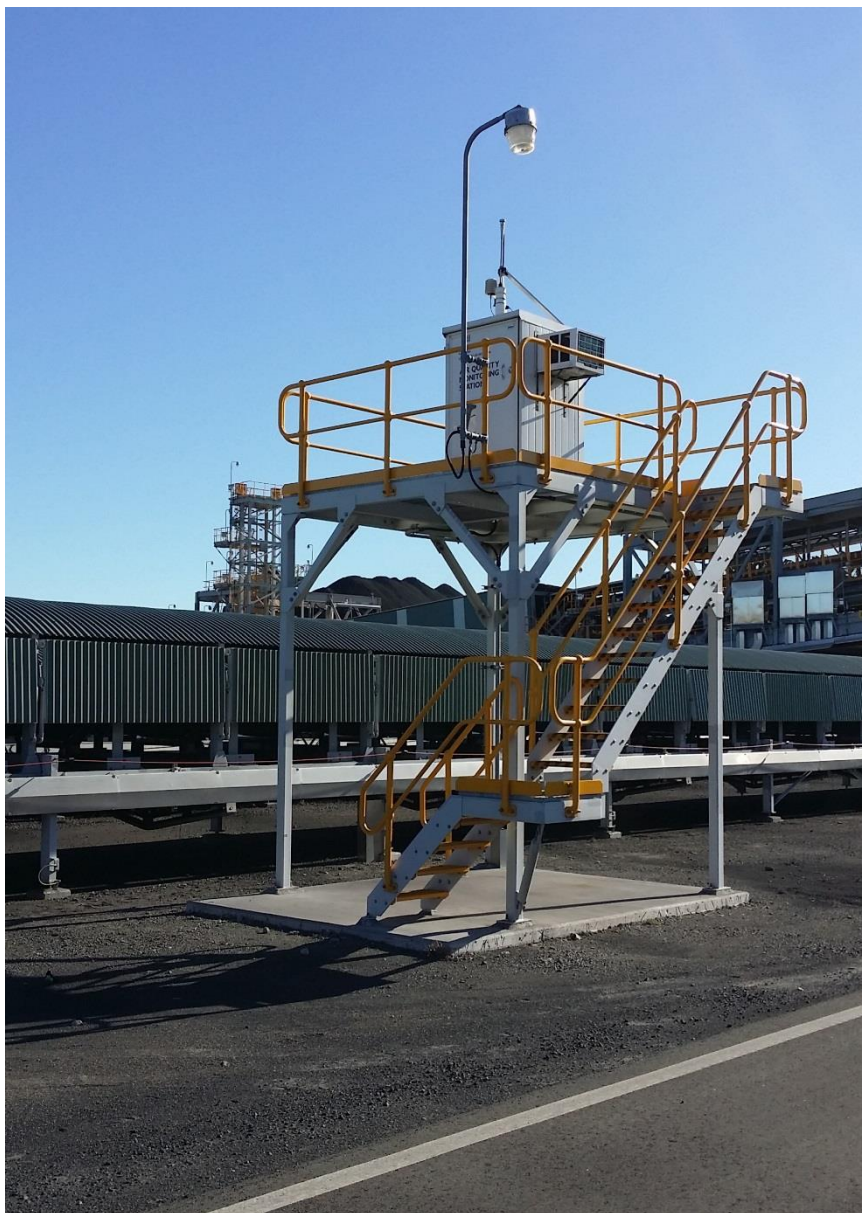
Figure 32: New Location of Eastern Dust Monitor

The eastern dust monitor was relocated in June 2014 from the upper level of Transfer House 6 to a dedicated elevated platform nearby location approximately equidistant between Transfer House 6 and Transfer House 7. Analysis of results from this monitor in its original location indicated that erroneous spikes in the data were corresponding with conveyor belt activity, particularly when the yard conveyors were in stacking mode and the belt sprays adjacent to the monitor were not in operation. Prior to its relocation, a one month trial was completed at the new location using a portable light-diffraction particulate monitor to ensure that the new location is not subject to the same erroneous readings that were occurring at the original location and to assess if other localised events are likely to disproportionately affect the location. The trial results indicated that the new location of the monitor is not impacted by localised conveyors or transfer houses. This dust monitor was placed on an elevated structure at the new location such that the inlet of the monitor is at approximately 4m elevation, as shown in Figure 32. The new location of the eastern dust monitor will assist in the understanding of dust issues crossing the NCIG boundary, in particular from the stockyard.
